VIRTUAL AUTOPSY OF NAZCA TRIDACTYL MUMMY ‘SEBASTIAN’

A scientific study using CT scan with advanced 3D image reconstruction and virtual dissection.

By **Dr. K.H. Fung** (Hong Kong SAR, China)

December 2025

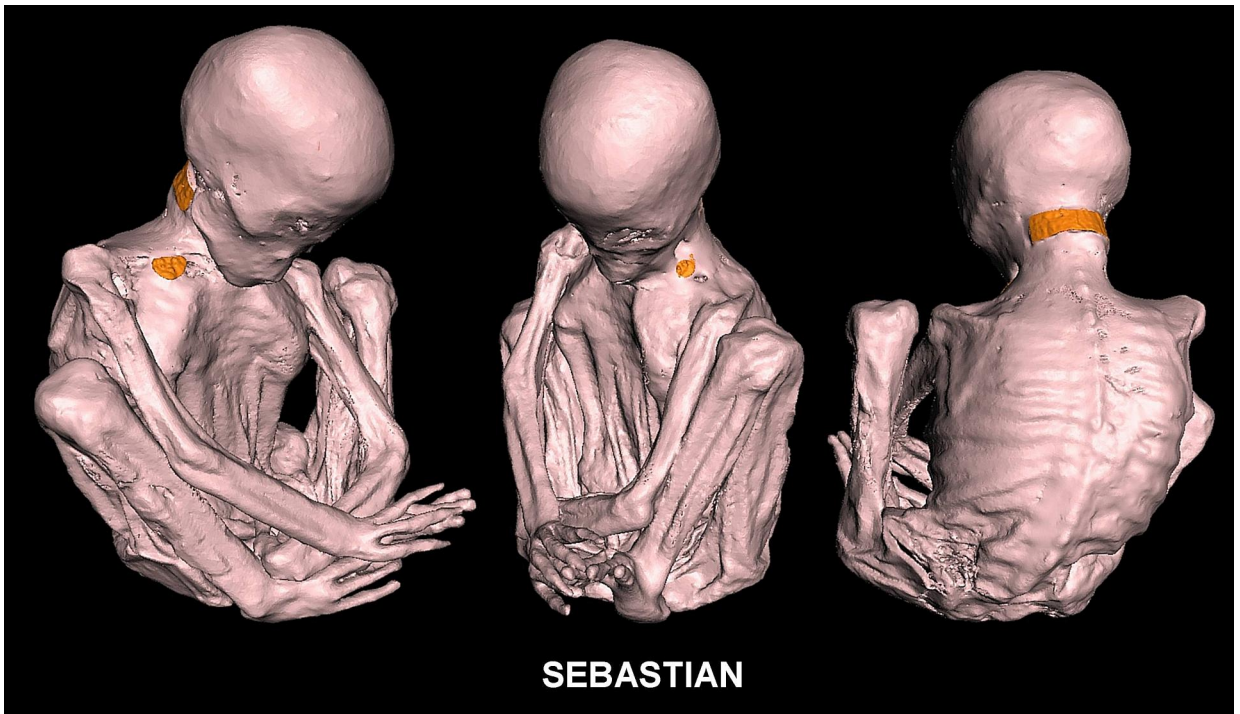
Figure 1: 3D CT of 'Sebastian' showing its surface anatomy in various projections. Note the foetal posture, tridactyl hands and feet and presence of 3 metallic implants (*in orange colour*).

- The gender cannot be definitively verified based on CT.
- It was found in a foetal position. (*Figure 1 &2*) The contracted and detached bi-lobed brain remnant was located in posterior aspect of the cranium suggesting that it had been in a dependent supine posture with head tilted towards the right side after death. (*Figure 3*)

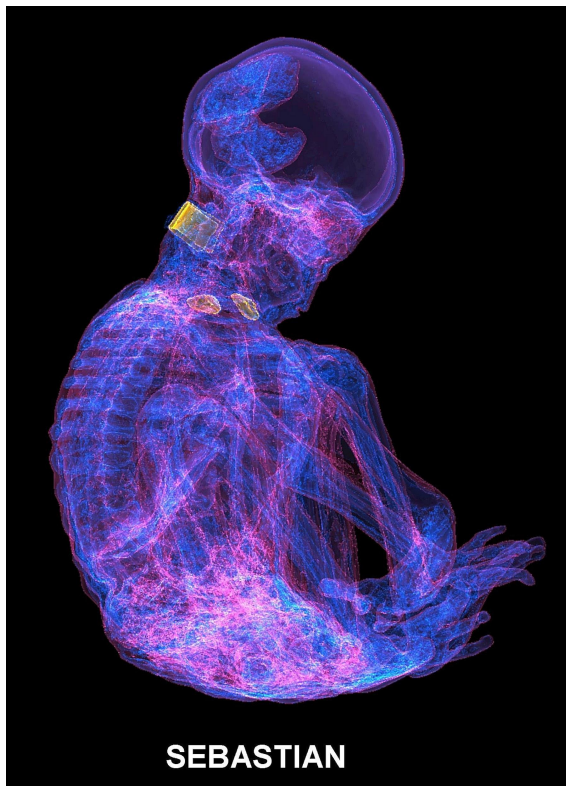
Figure 2: 3D CT of 'Sebastian' in semi-transparency showing skin, bones and metallic implants.

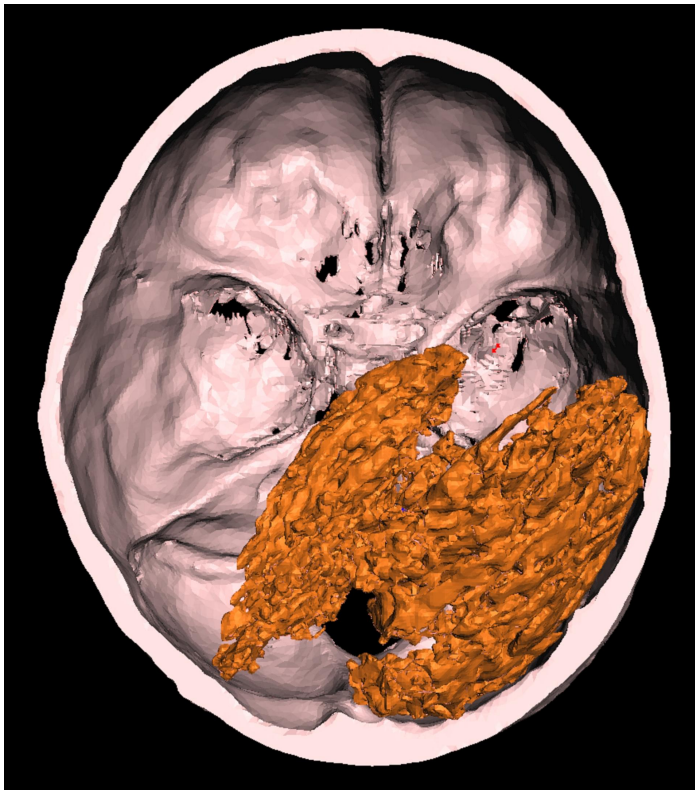
Figure 3: 3D CT of section of skull base. The bi-lobed brain remnant (*in orange colour*) can be seen in right side of posterior cranial cavity.

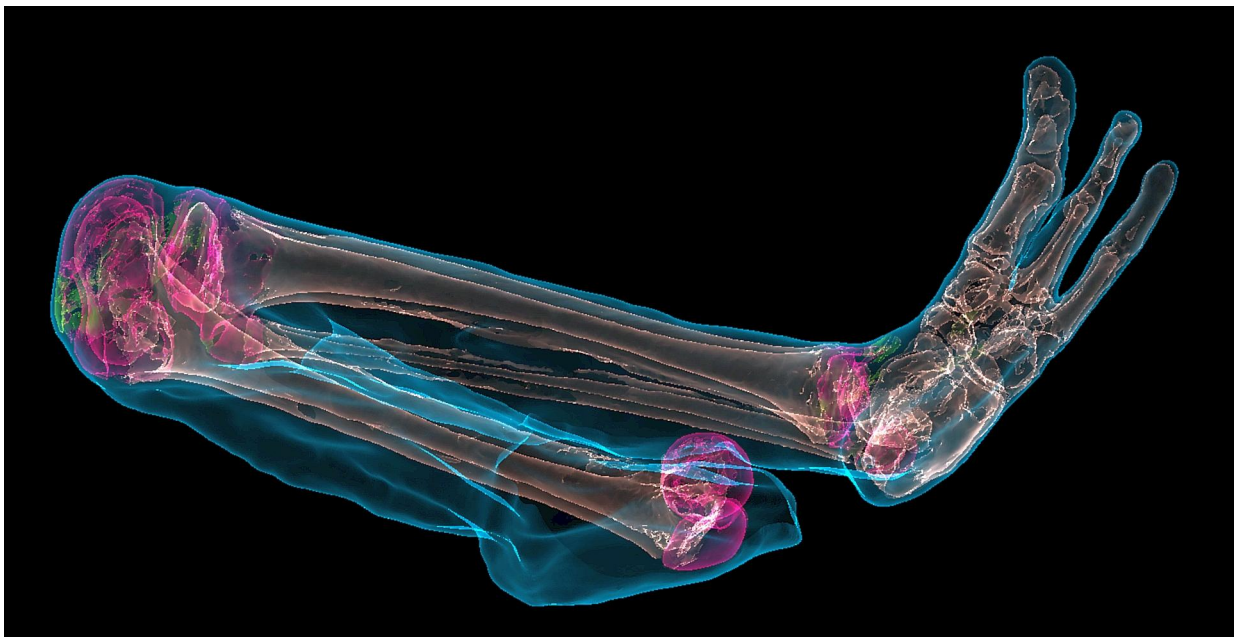
Figure 4: 3D CT of right lower limb showing presence of unfused epiphyses (*in lilac colour*) in long bones (*in yellow colour*). The skin is shown *in blue colour*. The tridactyl foot showed a more robust medial digit and weaker lateral digit. Note the wide spacing between the digits that is not found in human configuration. The counterparts of human metatarsal bones are incorporated into the digits. The tarsal bones arrangement remained similar to human configuration. Ligament and plantar fascia can still be found (*not shown*).

- There were evidences of biological consequences to injury suggesting that it had once been a living biological entity.
- It had unfused epiphyses in long bones (*Figure 4*) and some unerupted teeth (*Figure 5*) consistent with an immature skeleton of a child. An ectopic tooth was found on anterior surface of left maxillary antrum. (*Figure 6*)

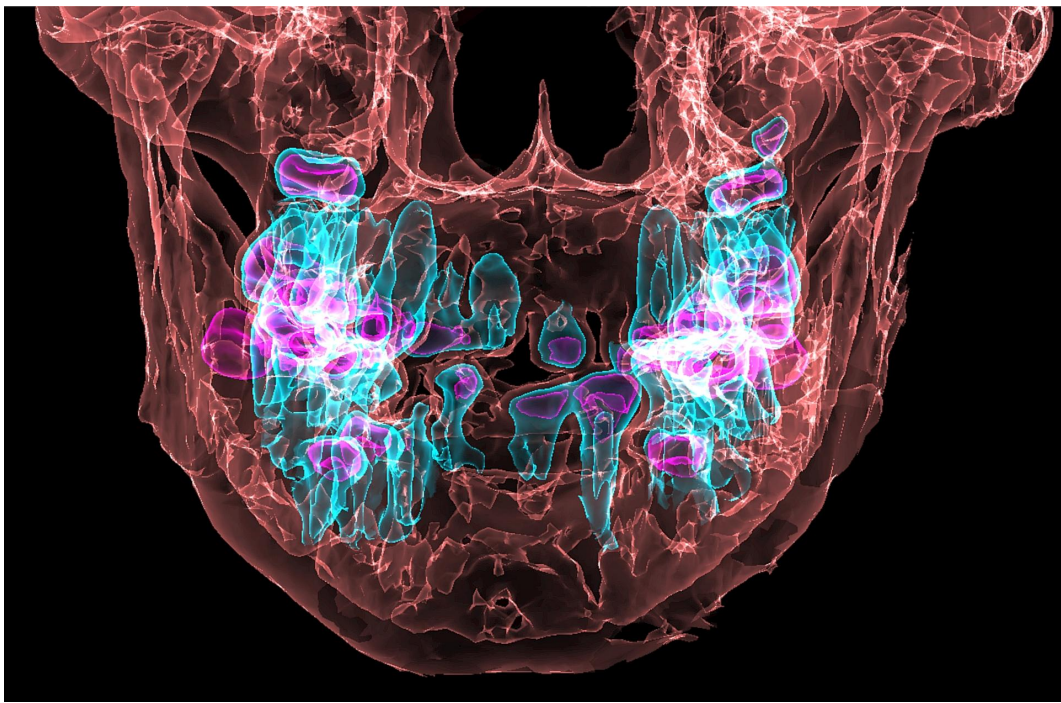
Figure 5: 3D CT scan of maxilla and mandible showing teeth (*in blue colour*), some remains unerupted. The crown of teeth are *in lilac colour*.

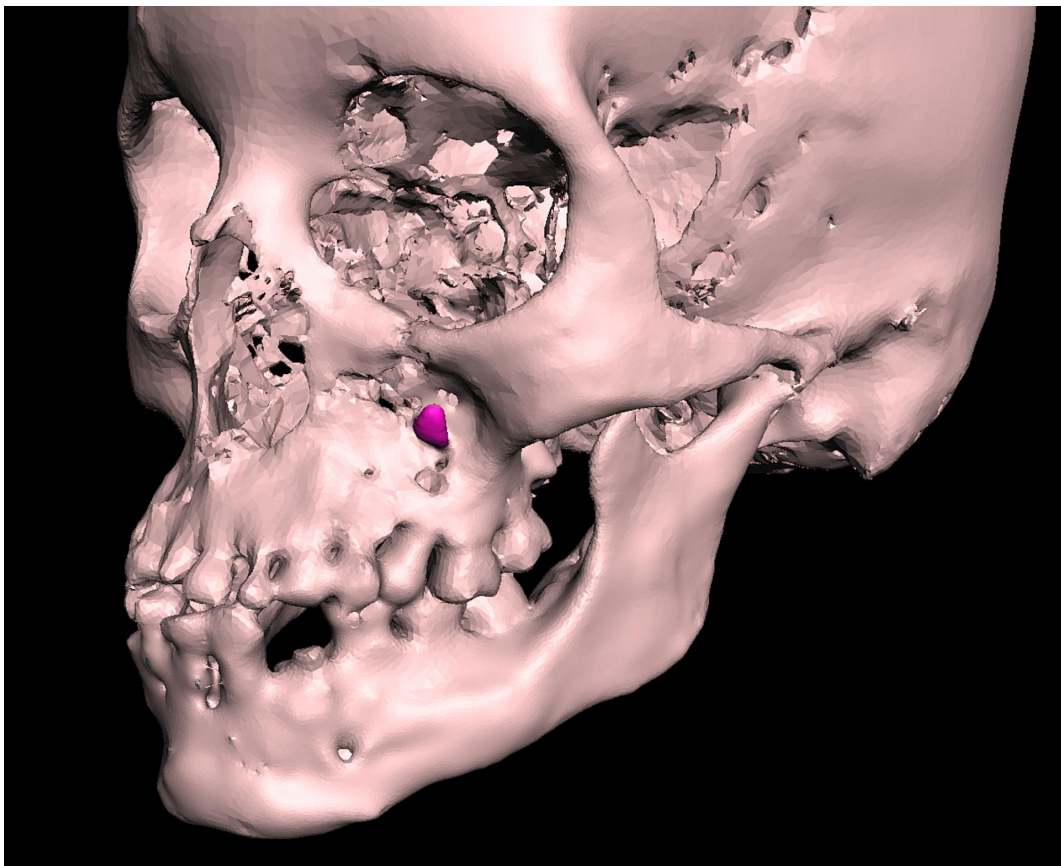
Figure 6: 3D CT scan of maxilla and mandible showing presence of an ectopic tooth (*in lilac colour*) overlying the anterior surface of the left maxillary bone. This is an extremely rare location to find ectopic tooth.

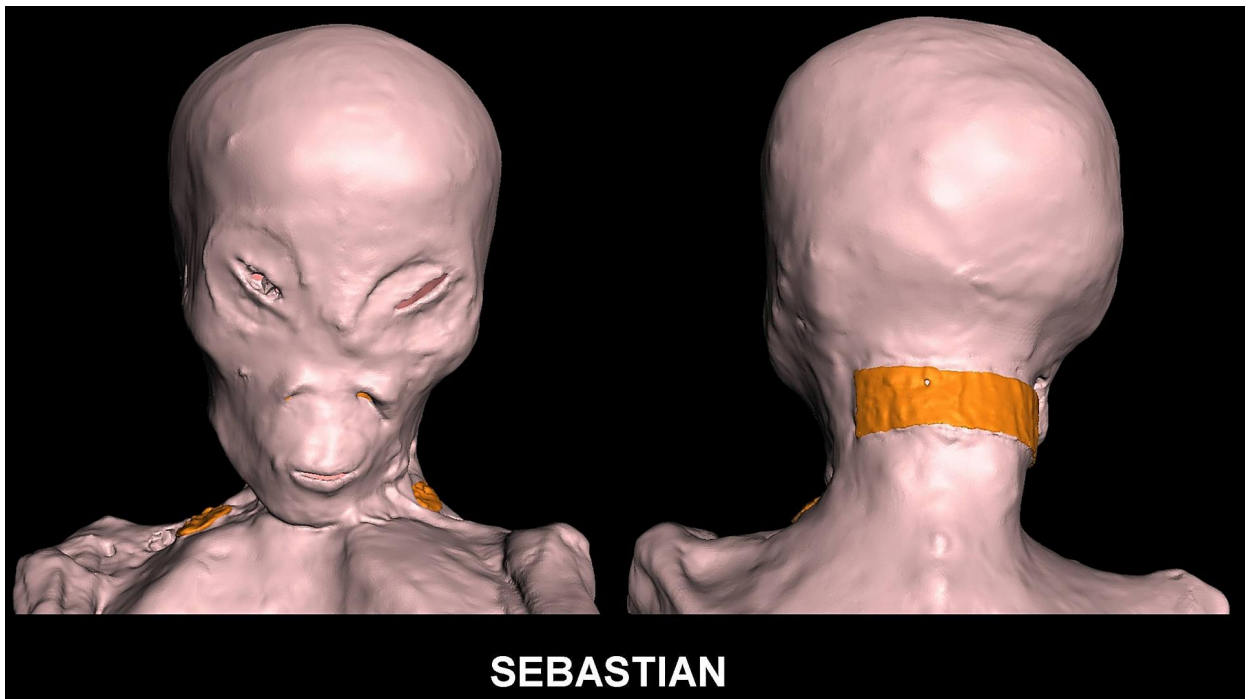
Figure 7: 3D CT showing front and back view of head. Note the widely separated large slanting eyelids, inconspicuous nose, flat downward and medial pointing nostrils, small face, prominent jaws and small pointed chin. Tiny skin nodules were noted in scalp and right side of face. Metallic implants were shown in orange colour.

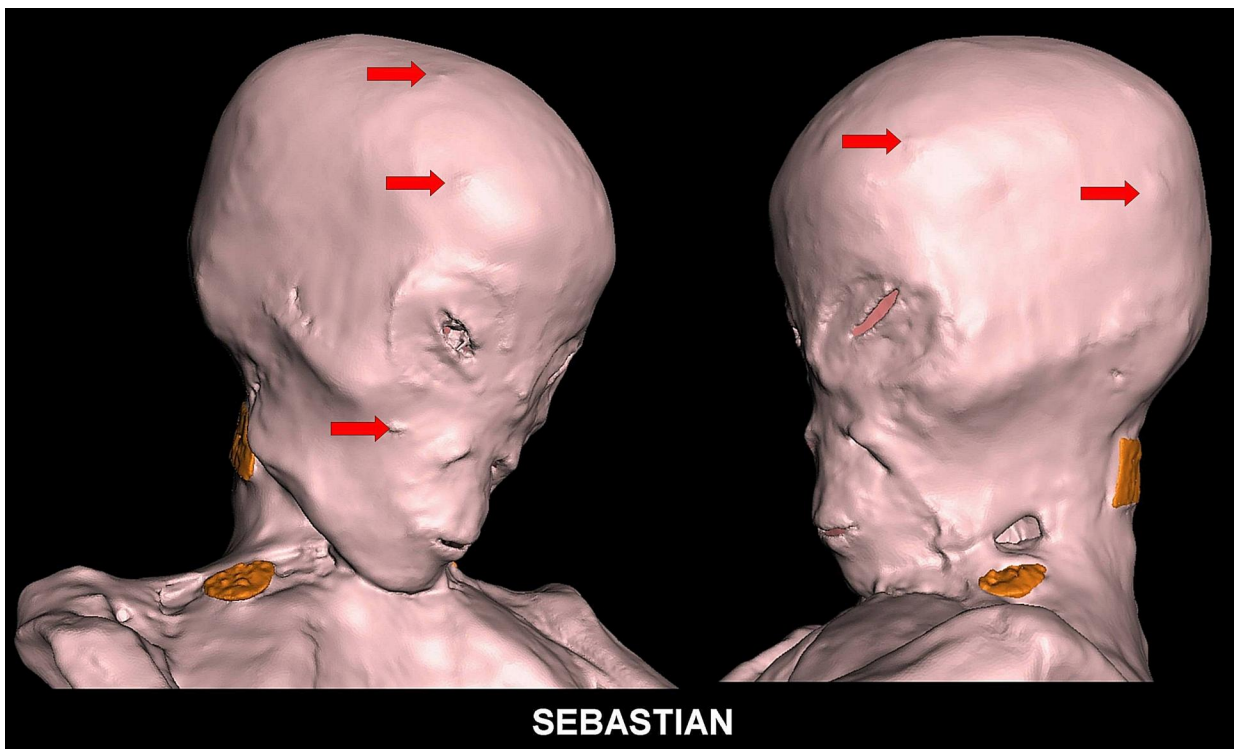
Figure 8: 3D CT showing oblique views of head and neck. Note absence of ear canal and pinnae. Metallic implants were shown in orange colour. Tiny skin nodules were noted in scalp bilaterally and in right face (*red arrows*).

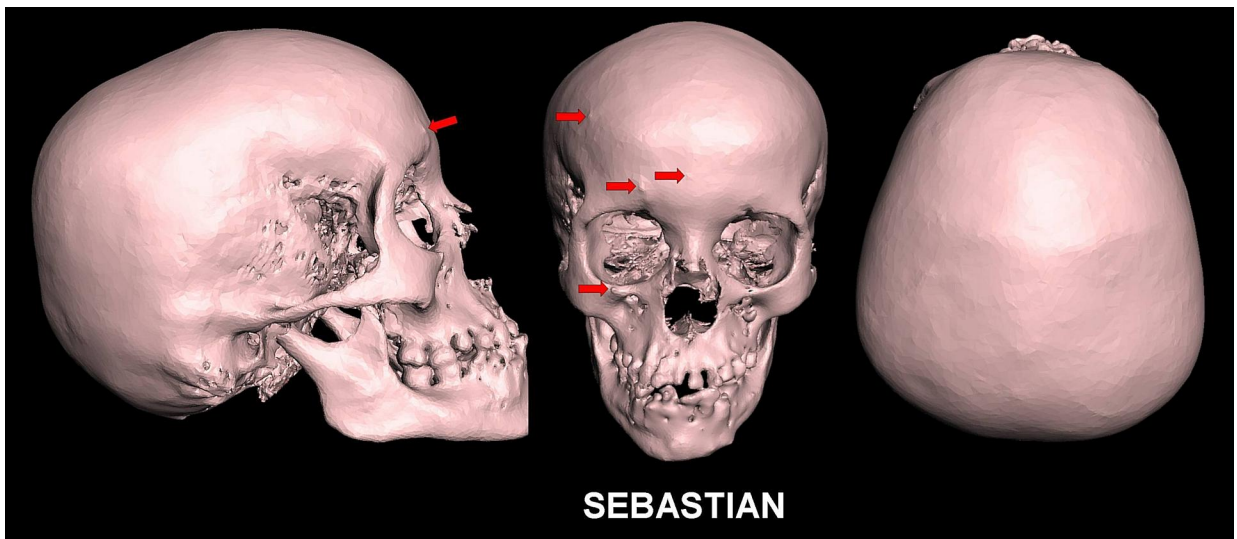
Figure 9: 3D CT showing right lateral (*left*), frontal (*middle*) and top views of skull (*right*). Cranial sutures were fused. No distinct skull sutures were visible on its surface. The cranium was not elongated. Facial bone were small with concave anterior surfaces. Orbits were enlarged. Prominent upper jaw showed asymmetry. Tiny bone nodules were noted in forehead and right facial bone (*red arrows*).

- Fused cranial sutures. *(Figure 9)*
- Scattered tiny nodularities in scalp and skull bone. *(Figure 8 & 9)*
- Oval shaped but posteriorly enlarged foramen magnum. *(Figure 10)*

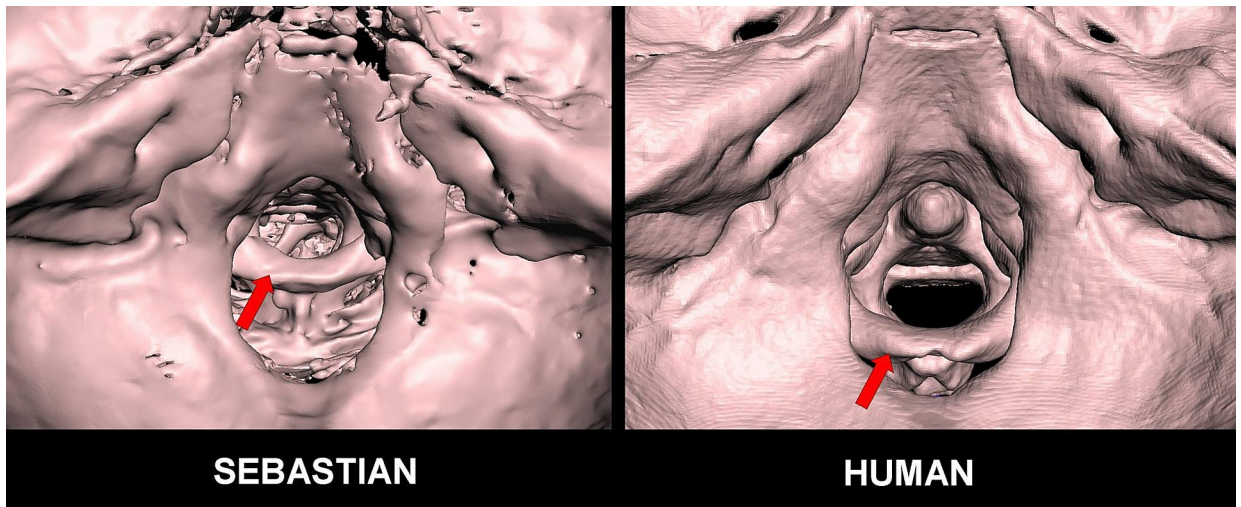
Figure 10: 3D CT showing foramen magnum viewed from above of ‘Sebastian’ comparing with modern human. Note the posterior extension of the foramen magnum in ‘Sebastian’ relative to the posterior arch of atlas (*red arrows*).

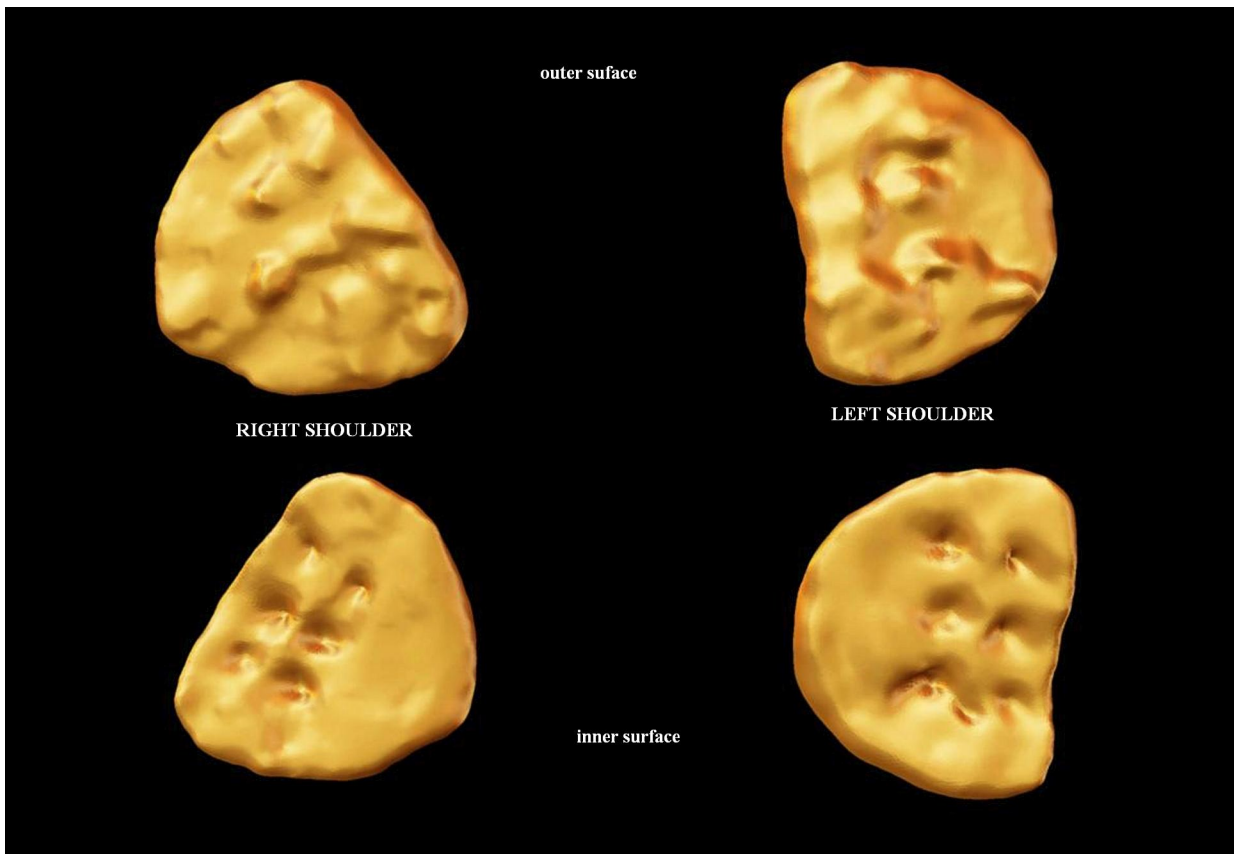
Figure 11: 3D CT showing disk shaped metallic implants with indentations overlying bilateral clavicles.

- Disk like metallic implant over bilateral clavicles with indentations. *(Figure 11)*
- Collar-like metallic implant in posterior neck showing relief markings on its outer surface. *(Figure 12)* There was suggestion of composite material with denser eccentric core. *(Figure 13)* Evidence of induced bone growth from spinous processes of C2 and to a minor extent C3 incorporating into the implant was evident. *(Figure 14)*

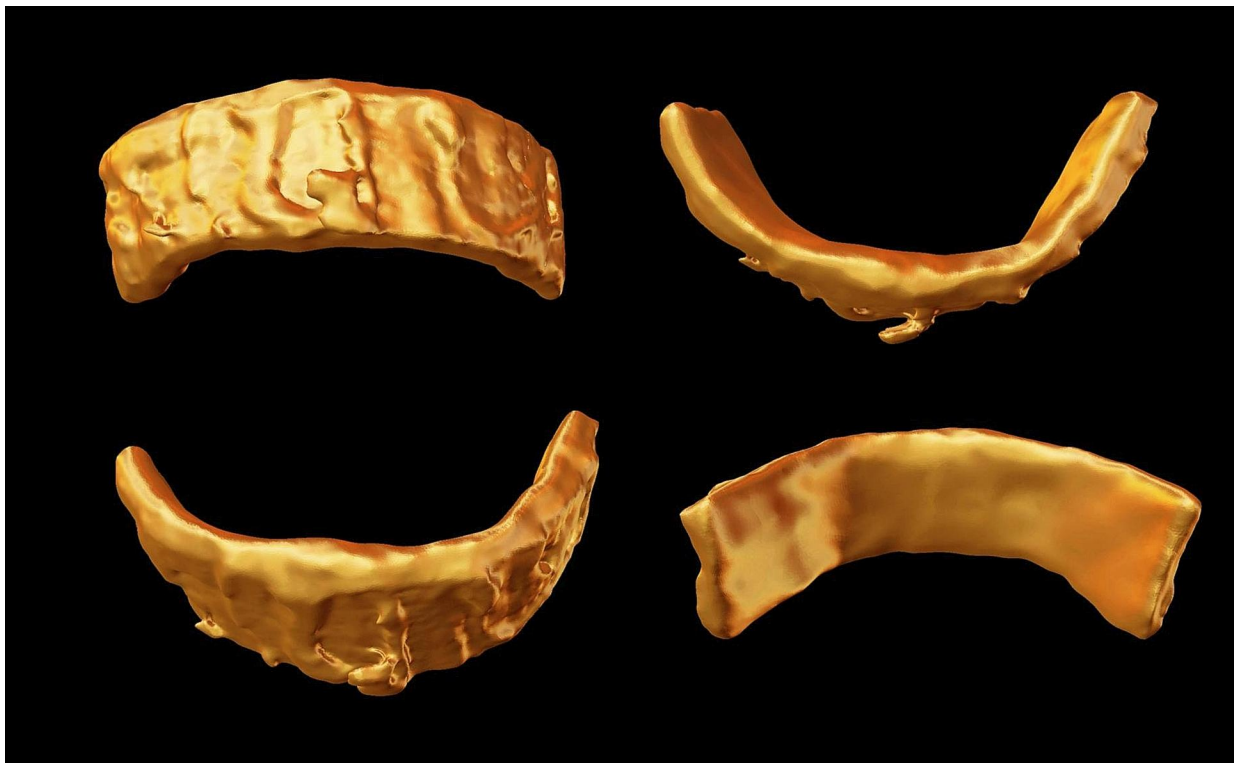
Figure 12: 3D CT showing collar-like metallic implant behind neck with relief markings on its outer surface.

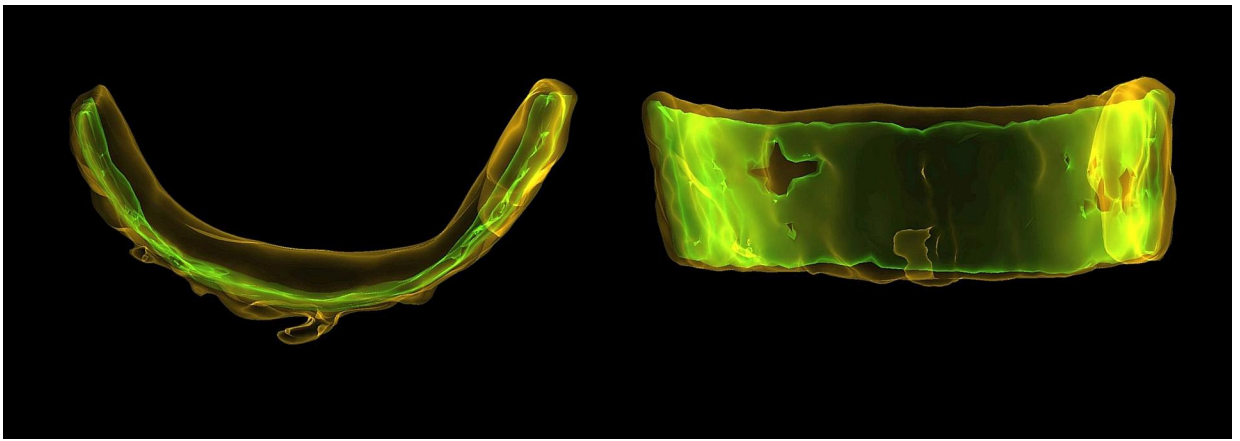
Figure 13: 3D CT of metallic neck implant in semi-transparency showing eccentric inner core with higher CT value (*in green colour*).

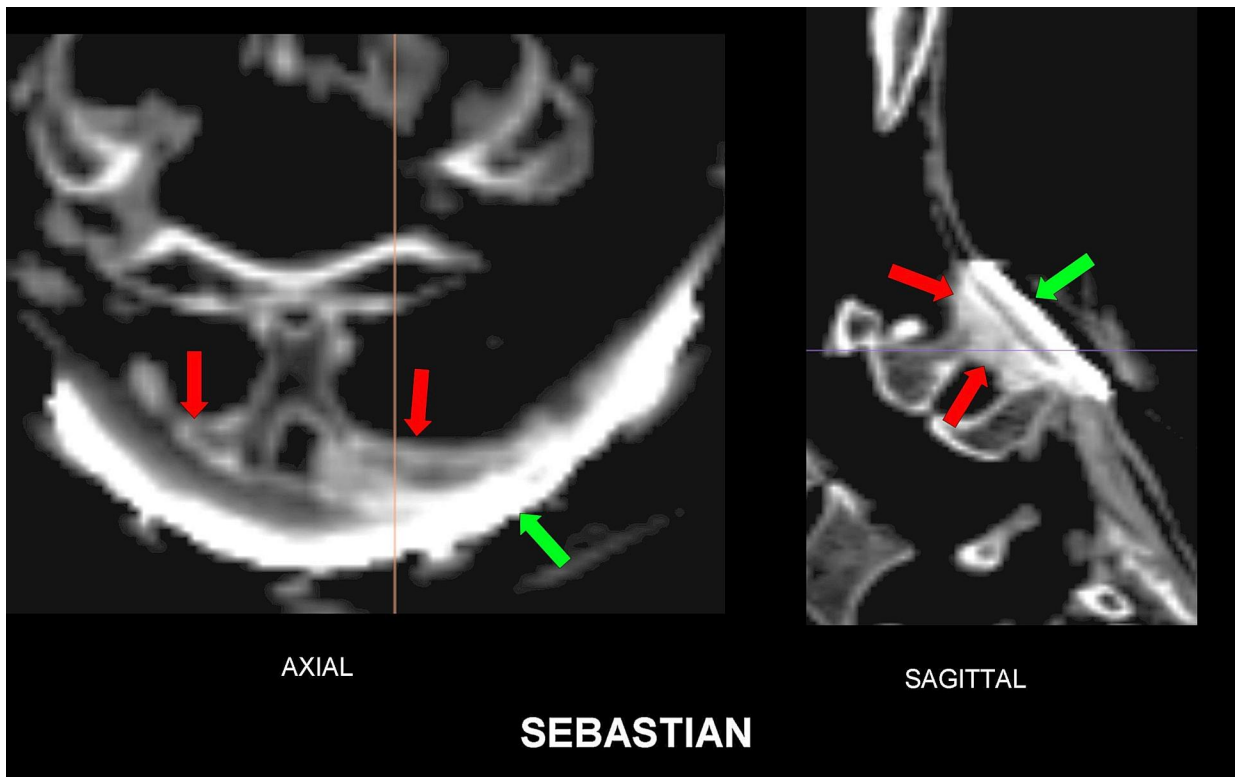
Figure 14: 2D axial (*left*) and sagittal (*right*) CT scans showing new bone formation (*red arrows*) from spinous processes of C2 and C3 incorporating into the collar like metallic implant (*green arrow*) in posterior neck indicating a functional implant.

- ‘Sebastian’ has 2 disk shaped metallic implants overlying bilateral clavicles and a collar shaped metallic implant behind the neck. A clinically very significant finding is the presence of florid new bone formation from cervical spine that fused with the implant.

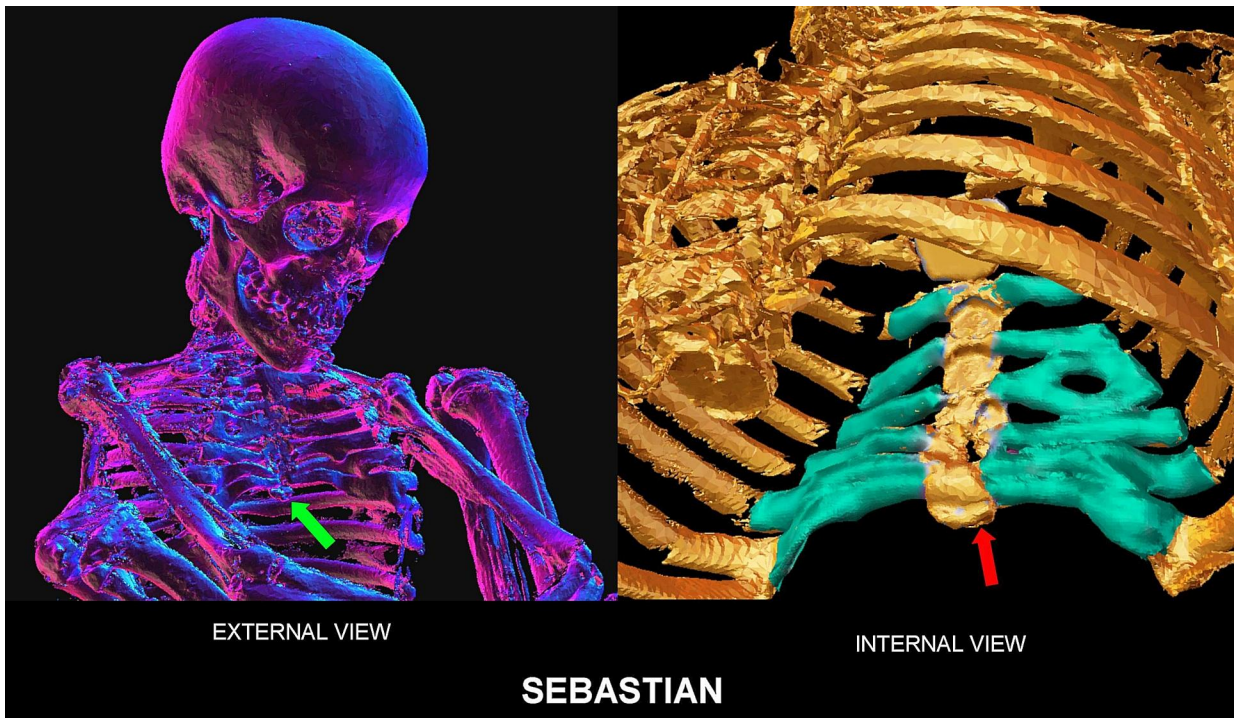
Figure 15: 3D CT of thoracic cage highlighting deformed, horizontally orientated robust costal cartilages with U-shaped deformity causing pectus excavatum. *Arrows* point to xiphisternum.

- Heavily calcified robust costal cartilages forming U-shaped deformity with depressed sternum (i.e. pectus excavatum). *(Figure 15)*
- Heavily calcified intervertebral disks in thoracic and lumbar spine. *(Figure 16, 38)*

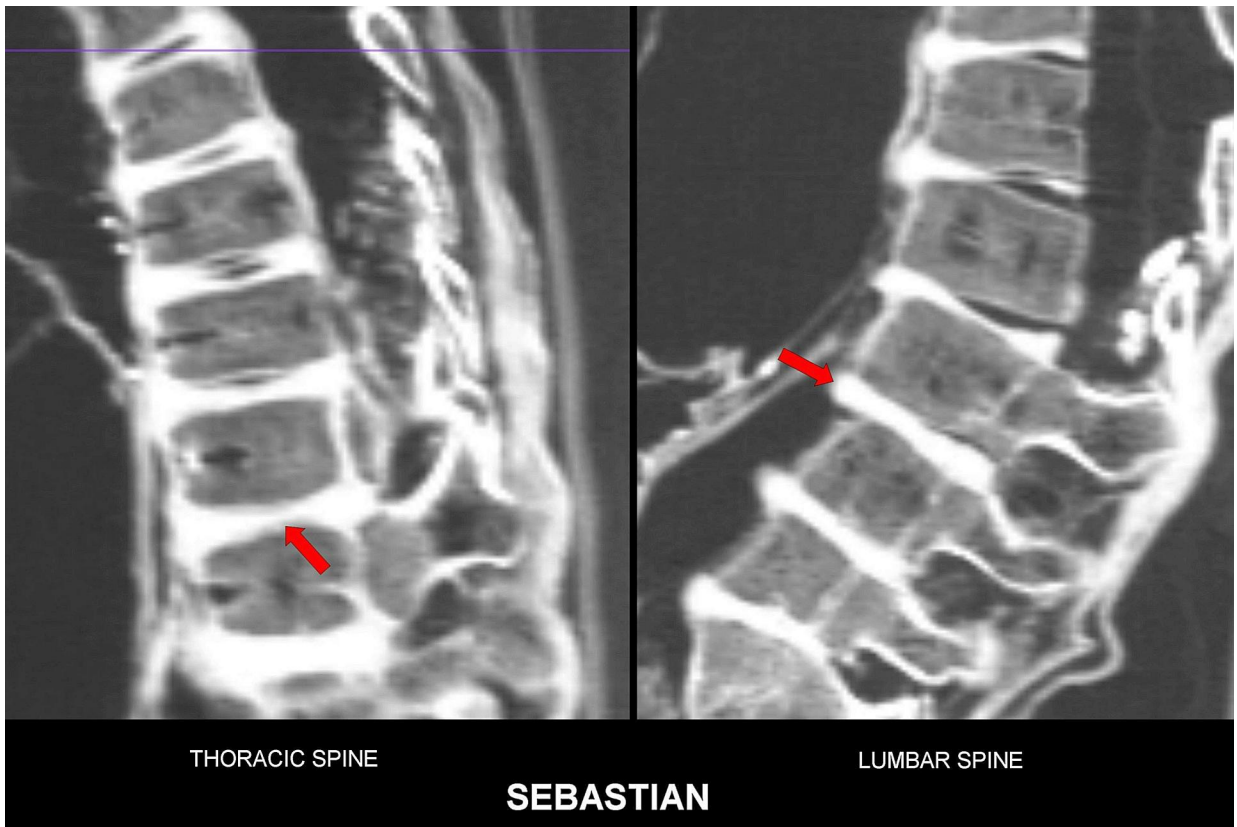
Figure 16: 2D sagittal CT scans showing heavily calcified intervertebral disks (*red arrows*) that showed higher density as compared with bone in thoracic (*left*) and lumbar (*right*) spine.

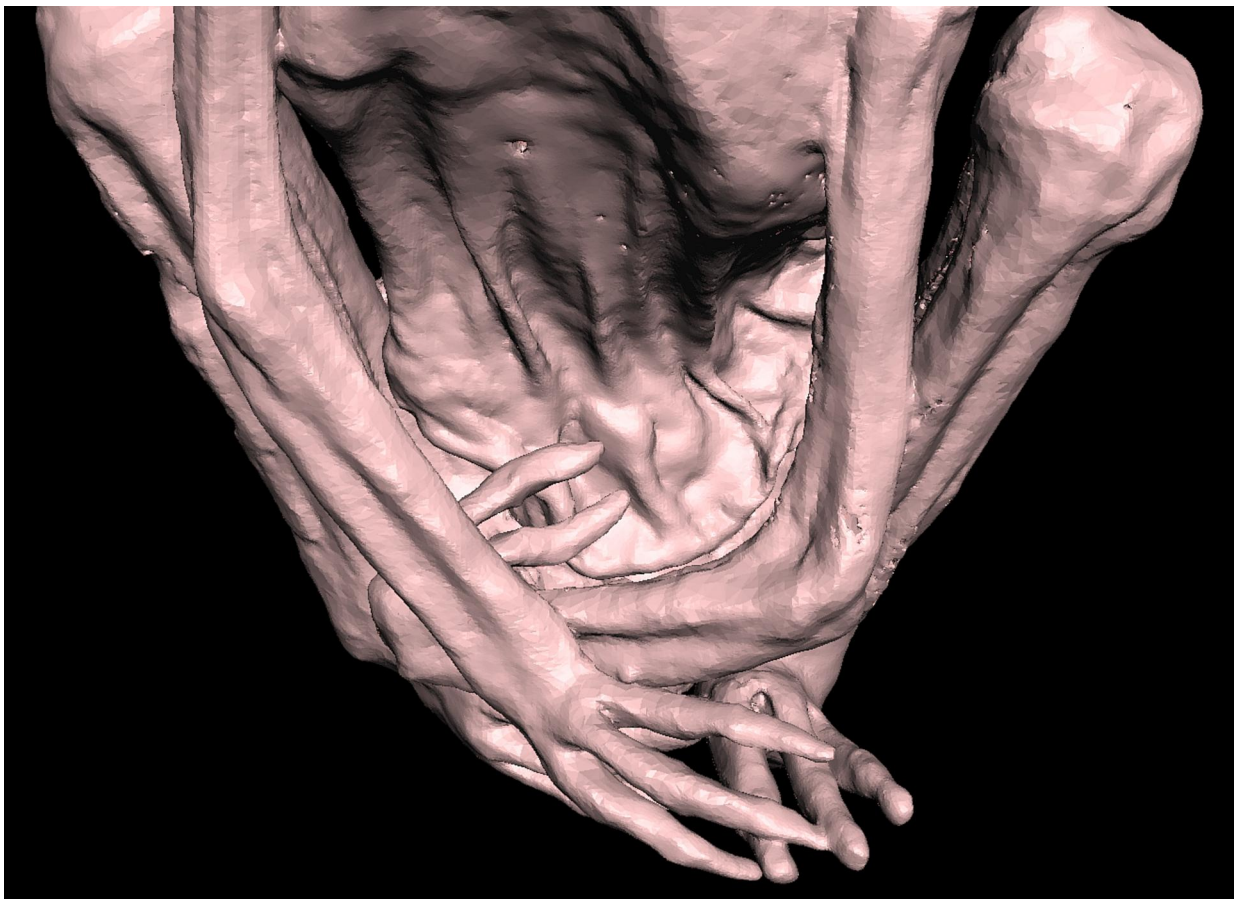
Figure 17: 3D CT showing prominent median abdominal fold and absence of navel.

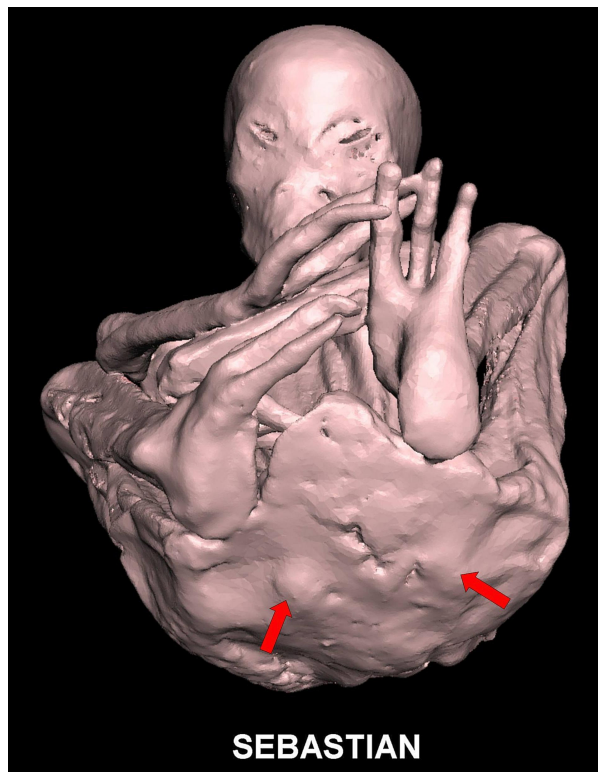
Figure 18: 3D CT showing flat triangular shaped perineum with lack of buttock prominences. Position of ischial tuberosities are marked. *(red arrows)*

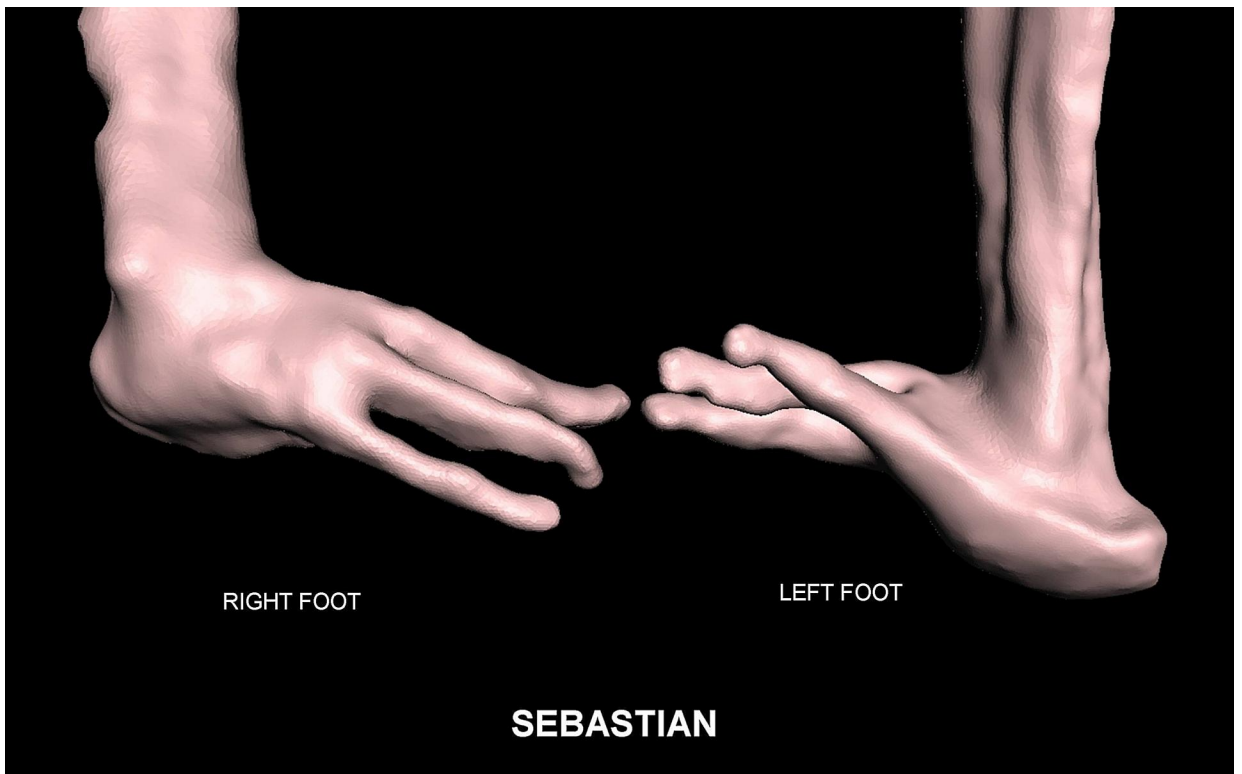
Figure 19: 3D CT showing 'rocker bottom foot' deformity in left foot.

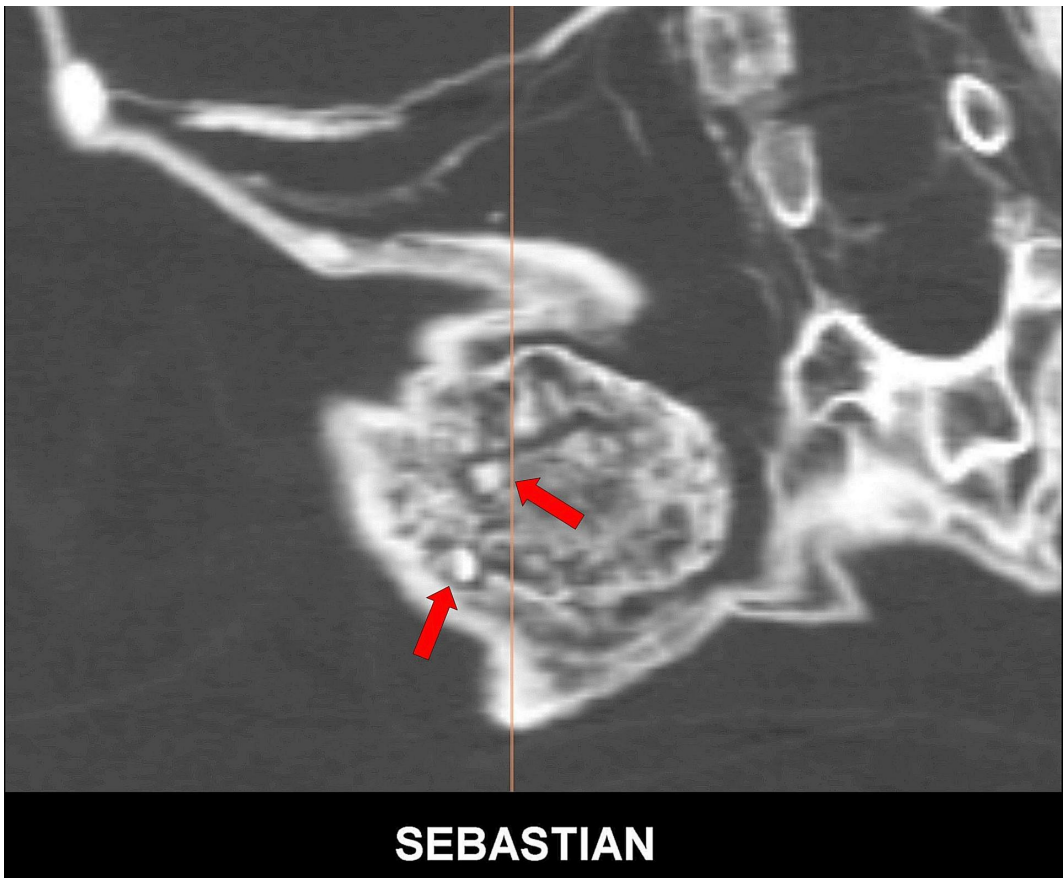
Figure 20: 2D coronal CT scan showing seeds within coprolites. (*red arrows*)

- Seeds were found in the coprolites suggesting a plant based diet.
- Disease processes were found including Tarlov cyst and presence of lung calcification (that may signify non-active pulmonary tuberculosis).

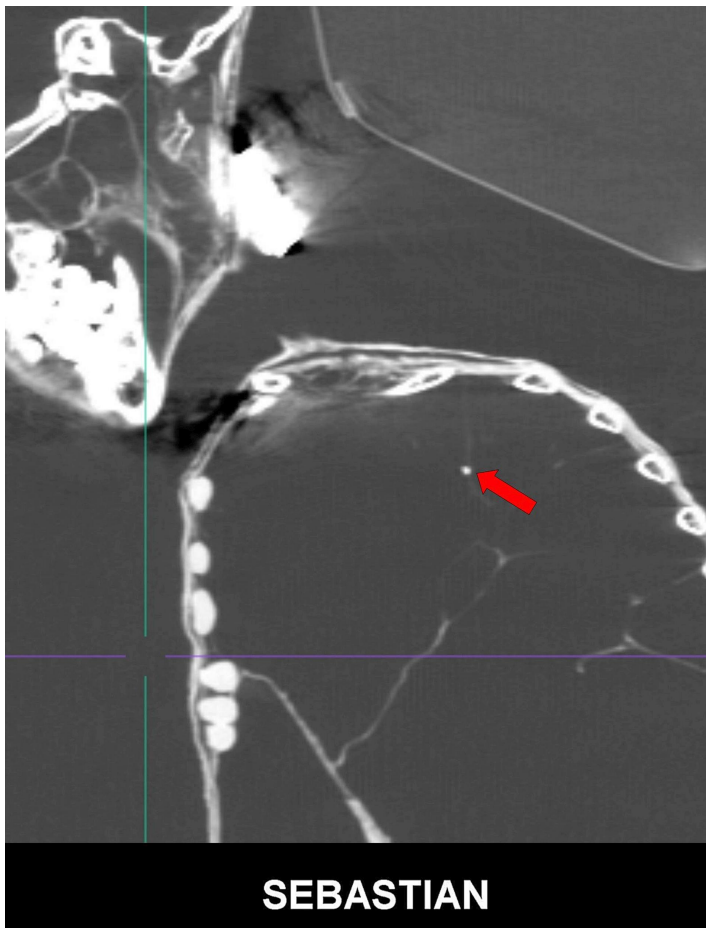
Figure 21: 2D sagittal CT scan showing calcified focus (*red arrow*) in upper lobe of left lung. Possibility of inactive pulmonary tuberculosis cannot be ruled out.

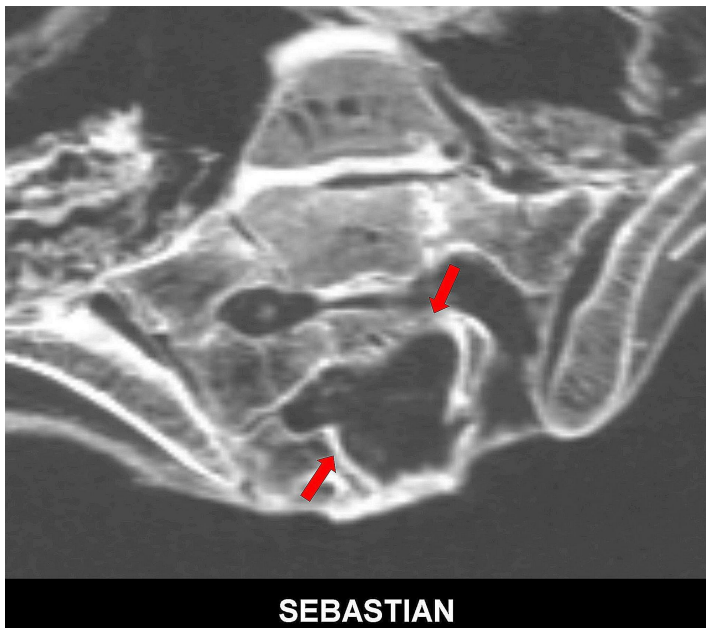
Figure 22: 2D coronal CT scan of sacrum showing well defined bony defect (*red arrow*) in left side of sacrum suggestive of Tarlov cyst.

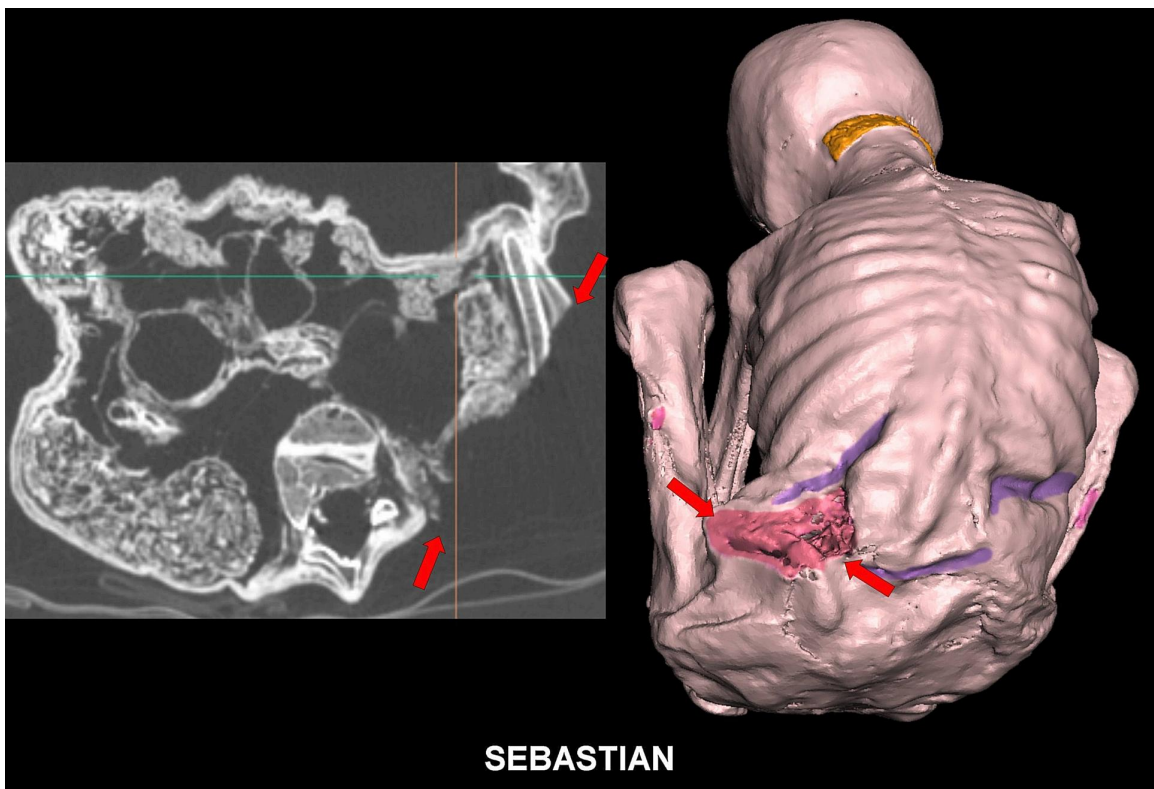
Figure 23: 2D axial CT scan (*left*) and 3D CT (*right*) showing large defect (*red arrows*) in bone and soft tissue over left posterior iliac area due to biopsy.

- A well defined triangular shape area of soft tissue and bone loss with clean sharp margin was noted in left posterior iliac region. This was related to recent biopsy site for tissue sampling. *(Figure 23)*

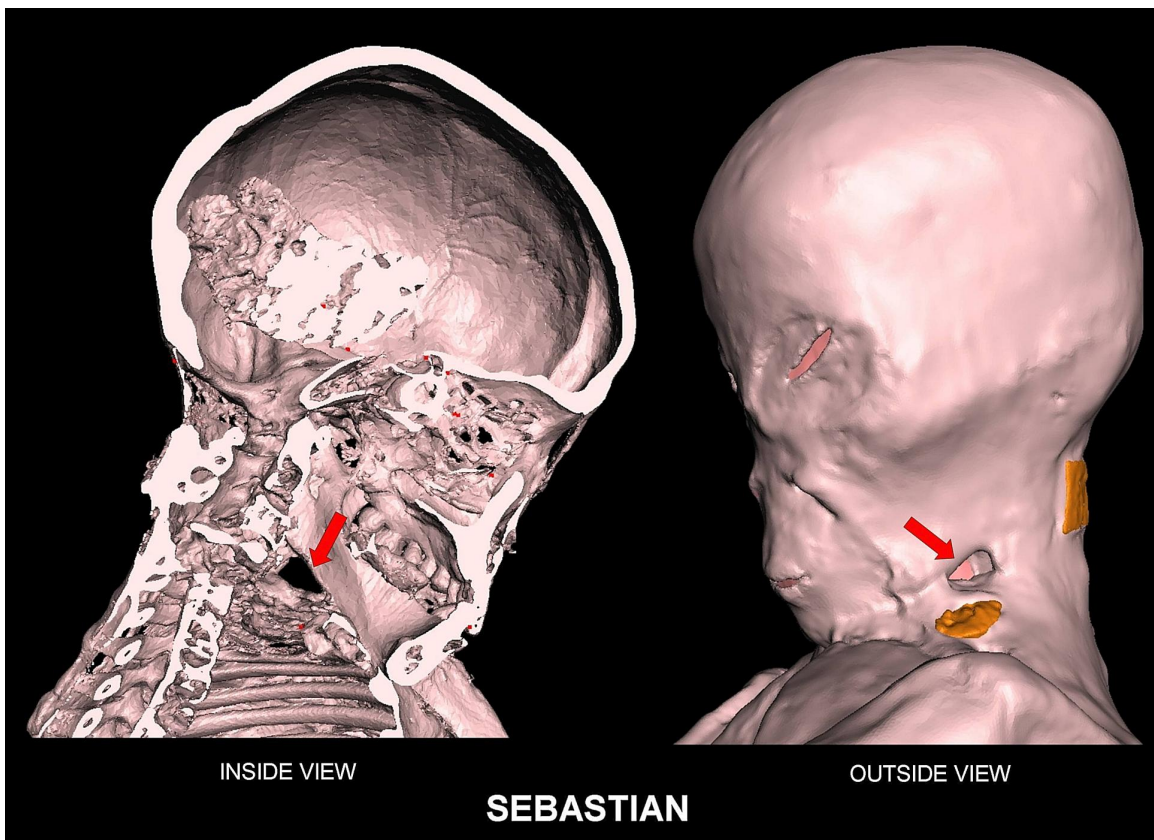
Figure 24: 3D CT showing inner (*left*) and outside (*right*) views of triangular shaped large puncture hole (*red arrow*) in left lower neck.

- A well defined triangular shaped puncture hole was found in lateral aspect of left lower neck. *(Figure 24)* The puncture hole led into a wide tract stretching across left side of neck ending anterior to C4 vertebra. *(Figure 25, 26)* A tiny metallic foreign body was found at the deep end of the tract anteriorly. *(Figure 26)* Associated hematoma was noted surrounding the tract, around mid cervical spine bilaterally and extending posterior to left paraspinal region and bilateral subcapital region above the metallic neck implant. *(Figure 25)* Bony destruction with anterior displacement and rotary subluxation of C4 was noted. *(Figure 27)*

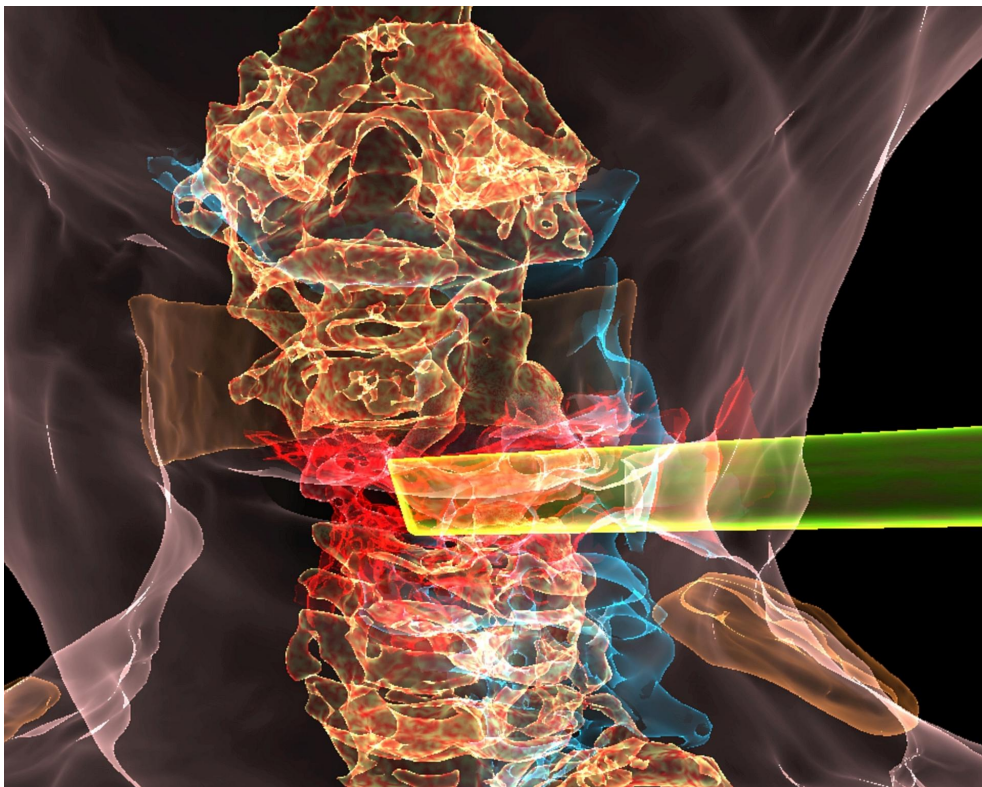
Figure 25: 3D CT frontal view showing proposed trajectory of penetrating object (*in green*), tissue tract (*in red*), associated hematoma (*in blue*) and cervical spine (*in orange*).
