VIRTUAL AUTOPSY OF NAZCA TRIDACTYL MUMMY ‘SEBASTIAN’

A scientific study using CT scan with advanced 3D image reconstruction and virtual dissection.

By **Dr. K.H. Fung** (Hong Kong SAR, China)

December 2025

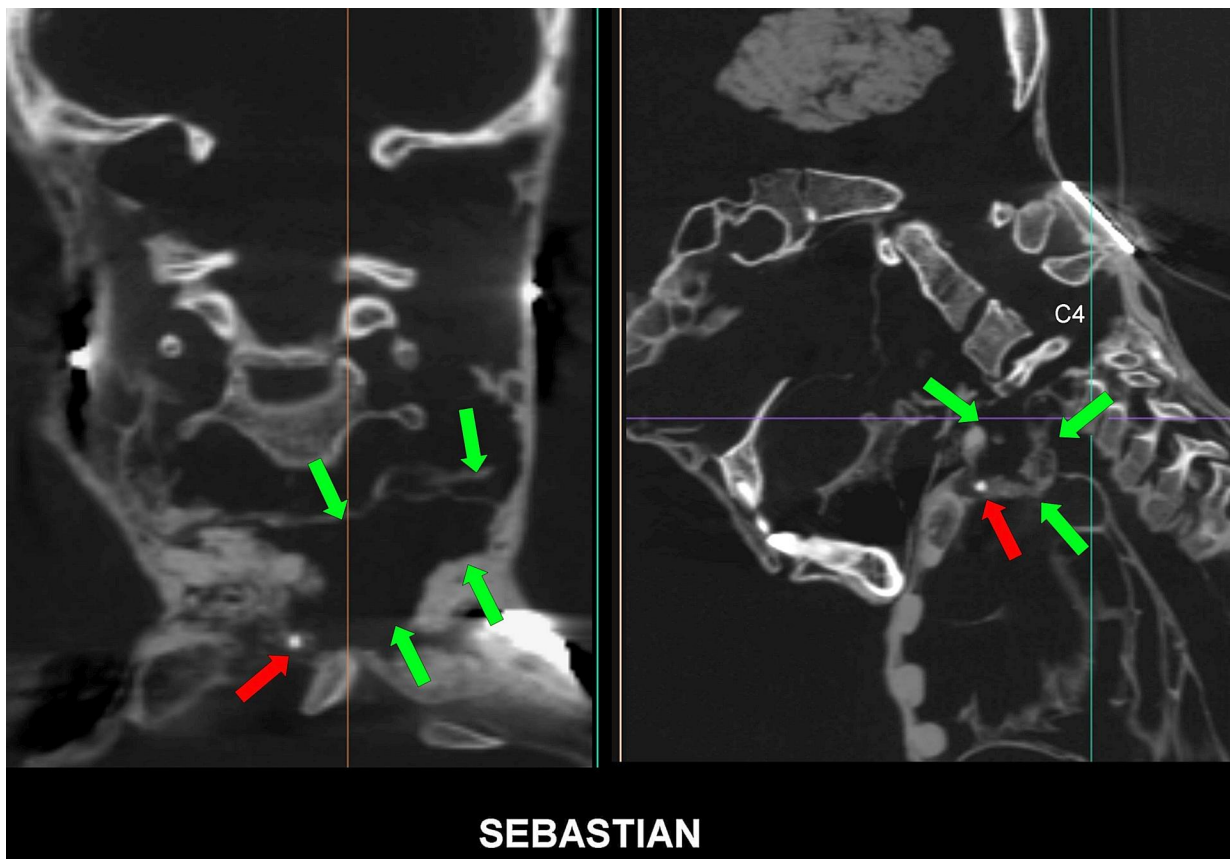
Figure 26: 2D coronal (*left*) and sagittal (*right*) CT scans showing wide tissue tract in neck (*green arrows*) with presence of small metallic foreign body (*red arrow*) at its inner end.

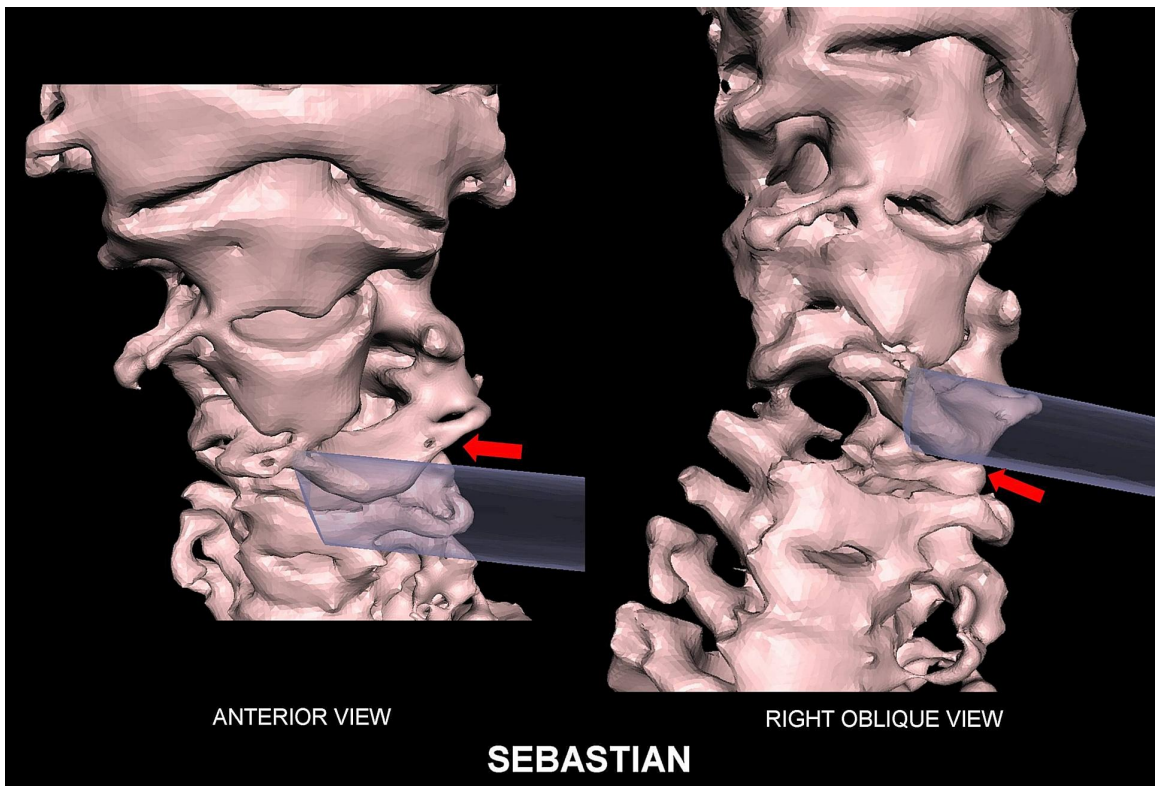
Figure 27: 3D CT showing frontal (*left*) and right oblique (*right*) views of cervical spine. Anterior displacement with rotary subluxation of C4 vertebra (*red arrow*) was evidence. Proposed trajectory of injuring object was shown in semi-transparency.

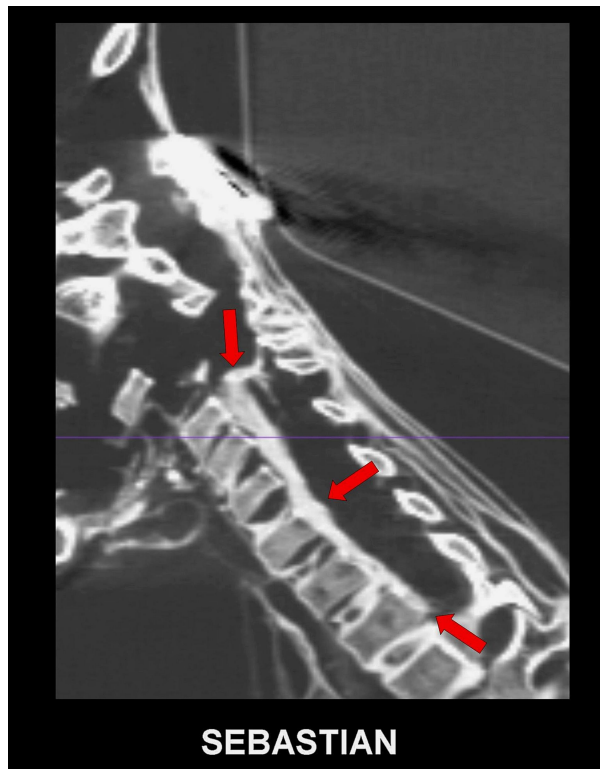
Figure 28: 2D sagittal CT scan showing epidural hematoma in anterior part of spinal canal related to C4 spinal injury extending from C5 to T3 levels.

- Associated epidural hematoma was noted in anterior spinal canal between C5 to T3 levels. *(Figure 28)*
- Two tiny metallic foreign bodies or focal calcifications were noted in spinal canal on right side at mid and lower thoracic levels. *(Figure 29)*

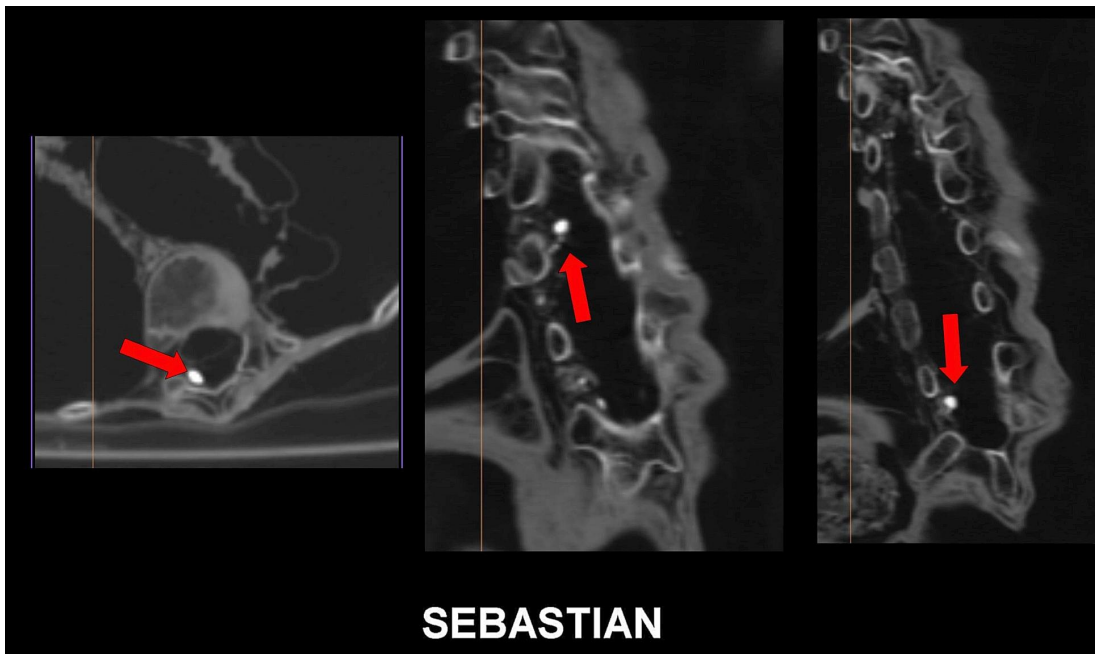
Figure 29: 2D CT scans in axial (*left*) and sagittal (*middle and right*) projections showing 2 metallic foreign bodies or calcifications (*red arrows*) in mid and lower thoracic spine.

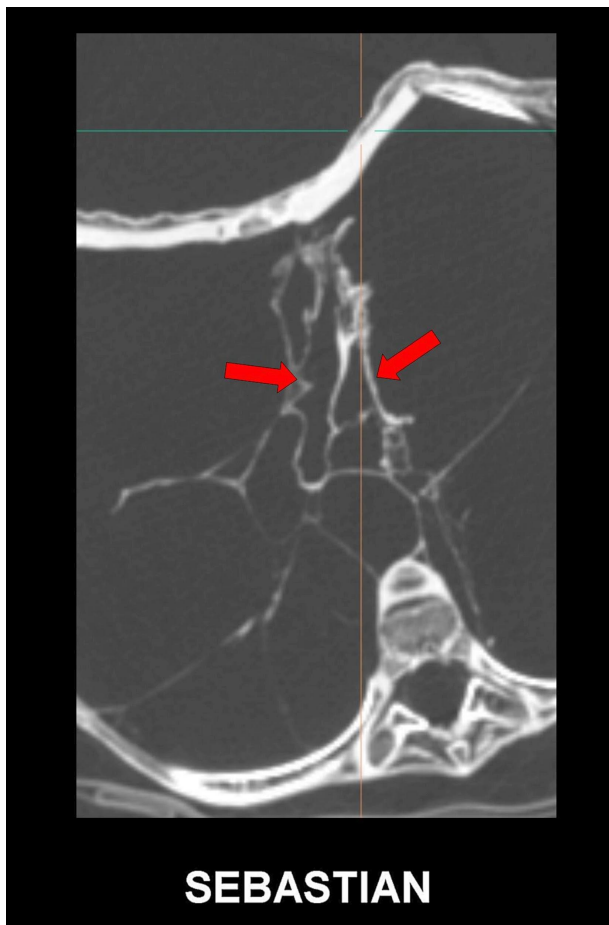
Figure 30: 2D axial CT scan showing partially collapsed heart (*red arrows*).

- Heart was partially collapsed. *(Figure 30, 39)*
- Deep wound with tissue loss was noted anteriorly medial to right shoulder. *(Figure 31)* The lateral part of upper epiphysis of right humerus was defective. *(Figure 31)*

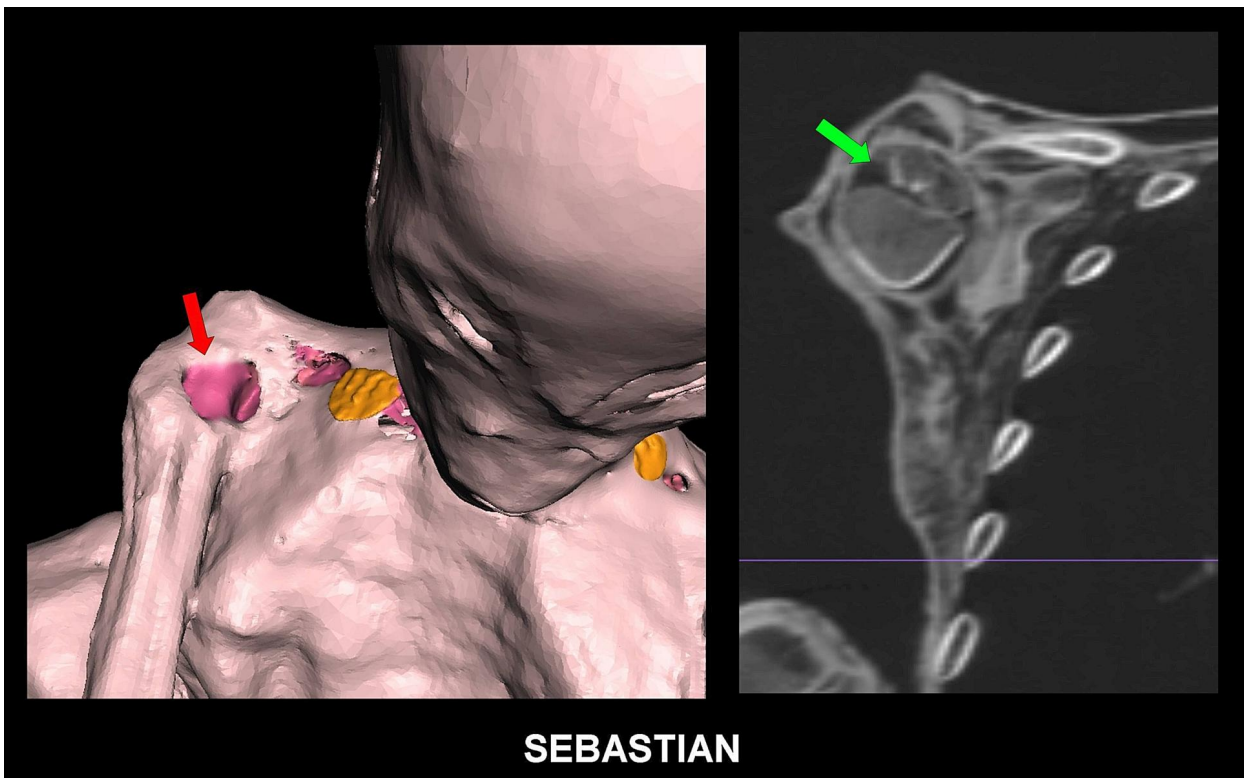
Figure 31: 3D CT (*left*) showing tissue loss (*red arrow*) over anterior medial aspect of right shoulder. Underlying destruction in lateral part of right upper humeral epiphysis (*green arrow*) can be found on 2D coronal CT scan (*right*).

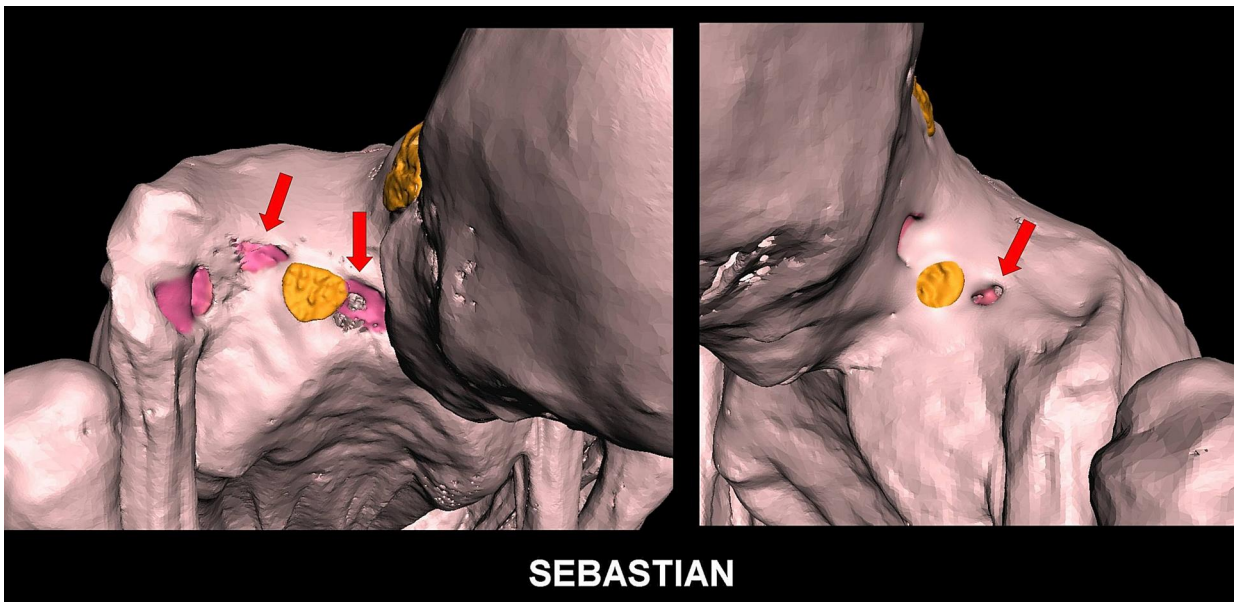
Figure 32: 3D CT showing tissue loss (*red arrow*) over right supraclavicular area (*left*). Puncture wound (*red arrow*) was noted lateral to metallic implant in left supraclavicular area (*right*).

- Wound with tissue loss were noted in right supraclavicular area medial and lateral to the metallic implant in that area. *(Figure 32)*
- Puncture wound was noted in left supraclavicular area lateral to the metallic implant in that area. *(Figure 32)*

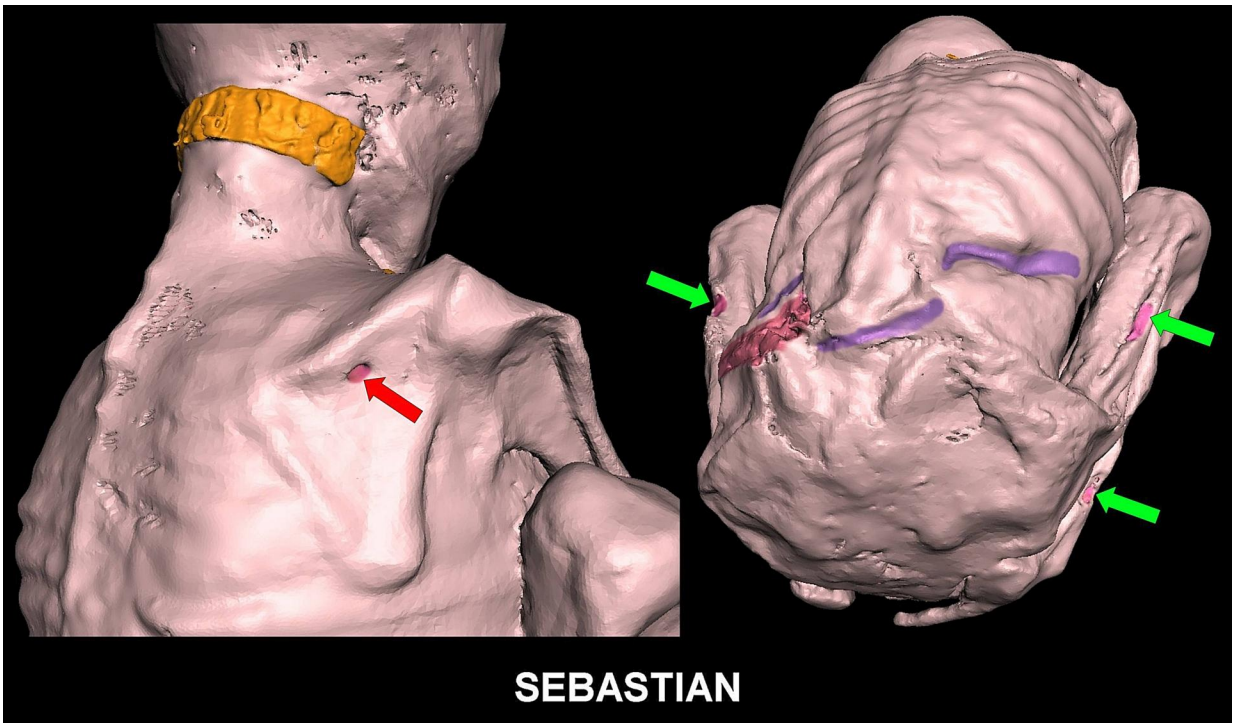
Figure 33: 3D CT showing puncture wound (*red arrow*) below right scapular spine (*left*). Areas of tissue loss (*green arrows*) were found in bilateral thighs and right leg (*right*).

- A puncture wound was noted in right scapula below scapular spine. *(Figure 33)*
- Smaller wounds with tissue loss were noted in upper anterior aspect of right thigh, mid anterior left thigh, anterior upper and posterior lower right leg. *(Figure 33, 34)*

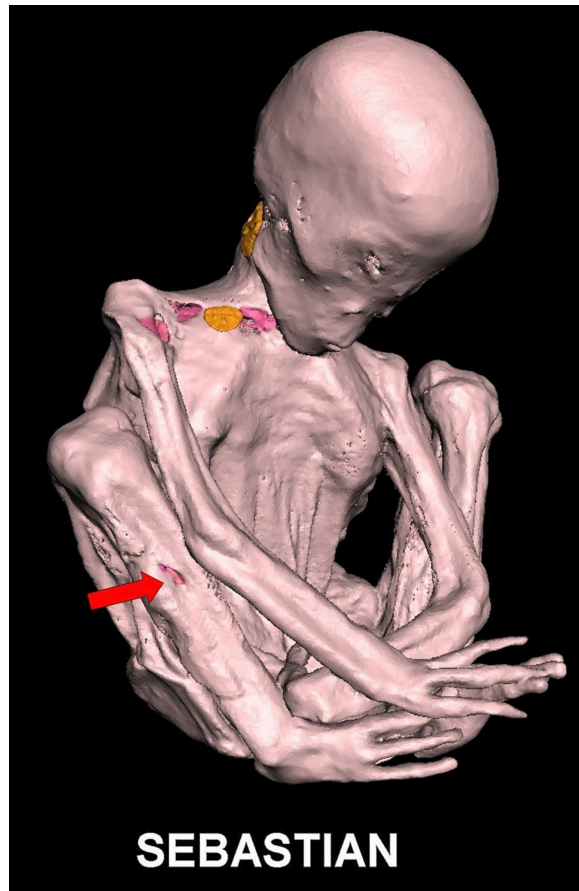
Figure 34: 3D CT showing wound (*red arrow*) in right shin.

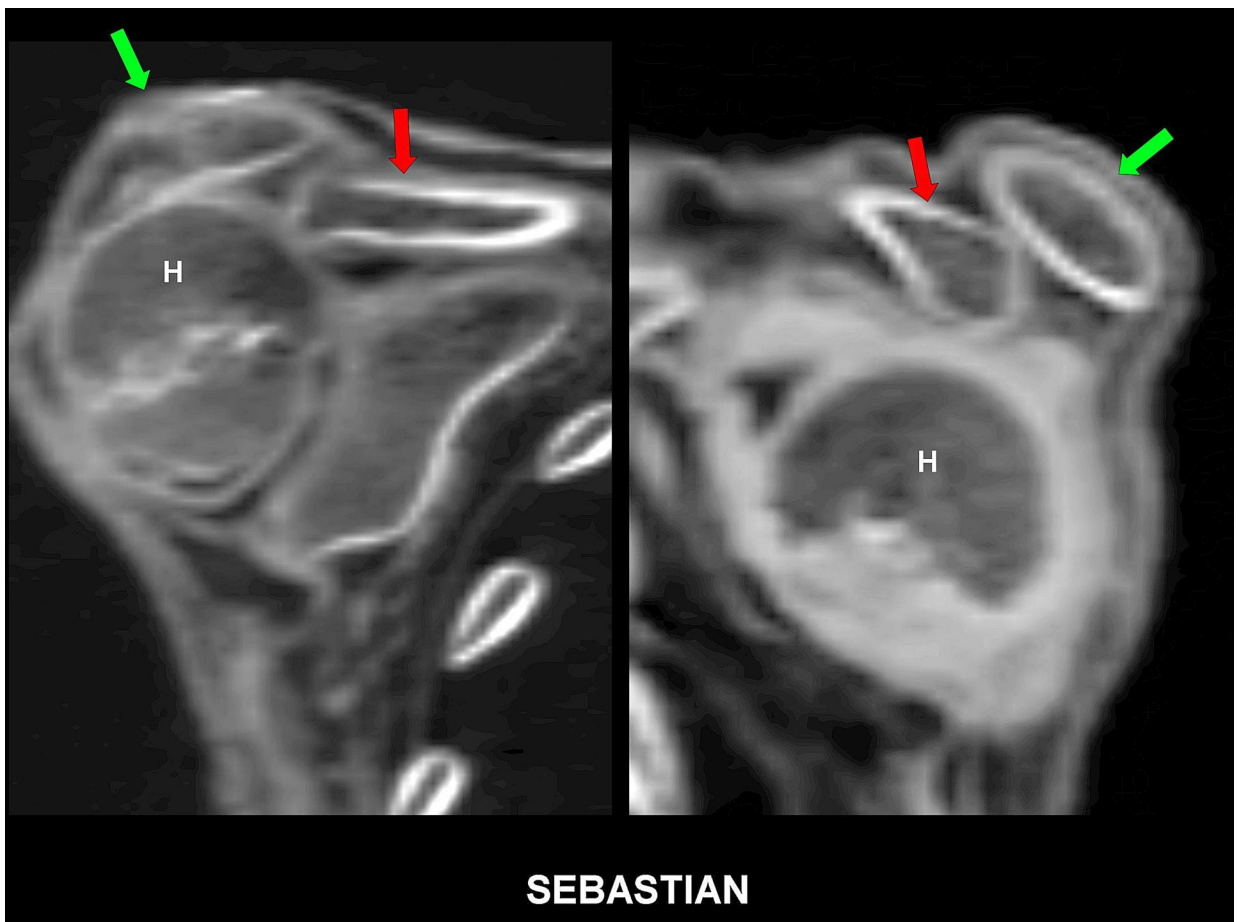
Figure 35: 2D coronal CT scan showing right shoulder (*left*) and left shoulder (*right*) both showing lateral ends of clavicles (*red arrows*) located below acromial processes (*green arrows*) and in contact with humeral head (*H*) suggestive of dislocation.

- Lateral ends of bilateral clavicles were dislocated and in contact with humeral heads. *(Figure 35)*
- Posterior and inferior dislocation of bilateral femoral heads were noted. *(Figure 36)* Femoral heads were normal looking.

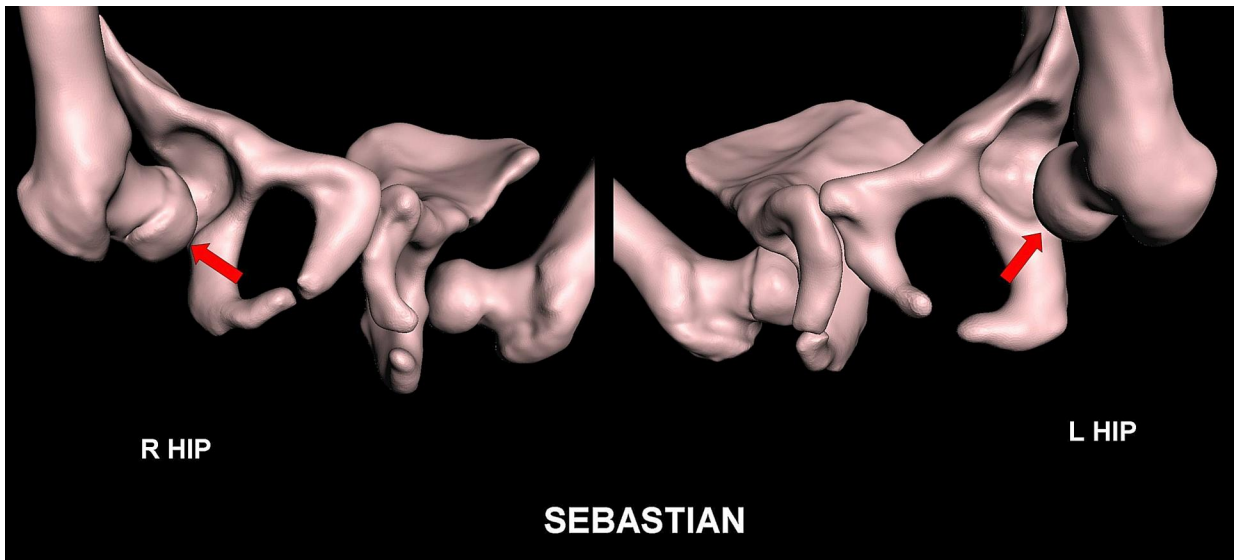
Figure 36: Recreated 3D models of pelvis and both hips based on 3D CT showing dislocation of both femoral heads (*red arrows*) from acetabuli.

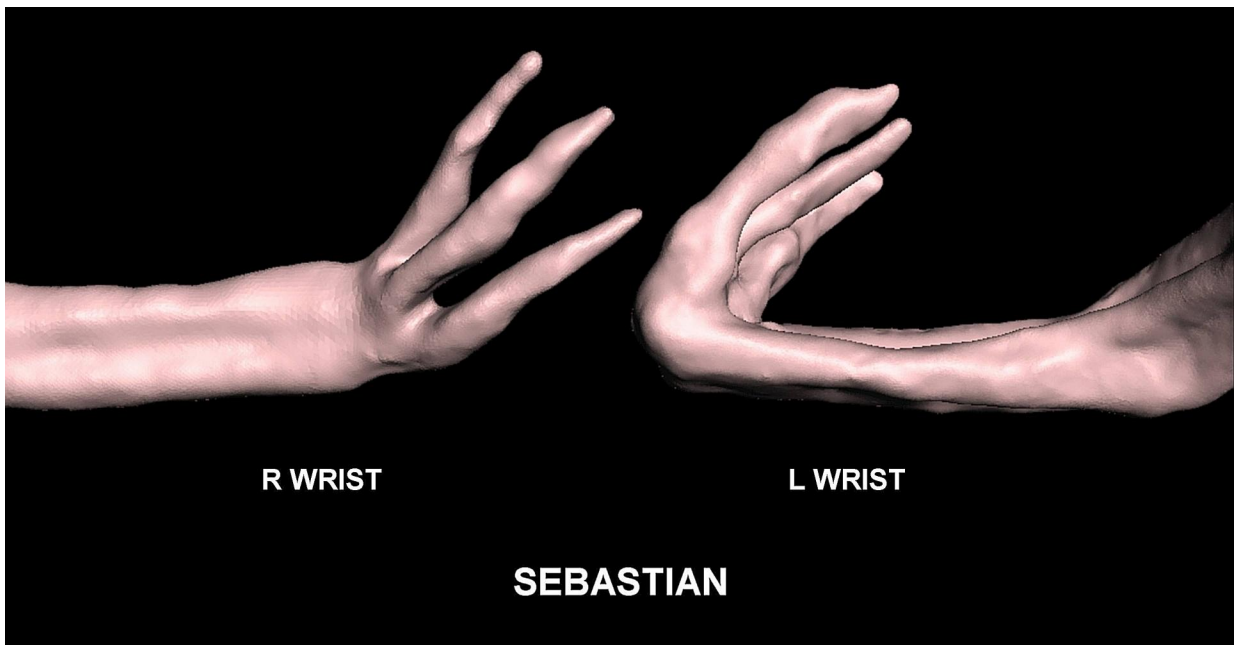
Figure 37: Bilateral hands and wrists showing hyper-flexion in left wrist. This could indicate hyper-mobility of the wrist joint or result of trauma.

- Hyper-flexion in left wrist was noted. *(Figure 37)*
- Lungs were hyperinflated with depressed hemi-diaphragms. There was evidence of bilateral haemothoraces and subphrenic hematoma crossing midline from right side. *(Figure 38, 39)*

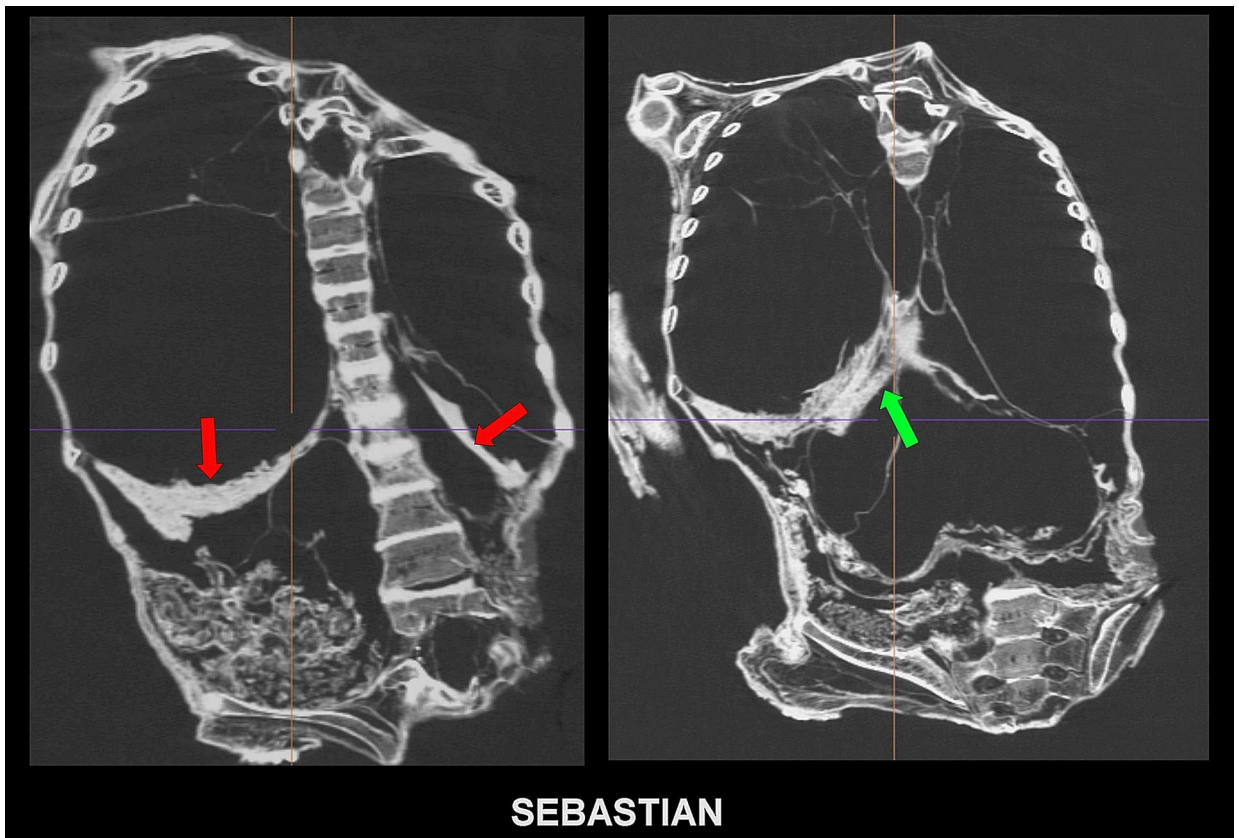
Figure 38: 2D CT scans in frontal projections showing presence of hyper-inflated lungs with depressed hemi-diaphragms and presence of bilateral hemo-thoraces (*red arrows*). Subphrenic hematoma (*green arrow*) crossing midline from right side was also noted.

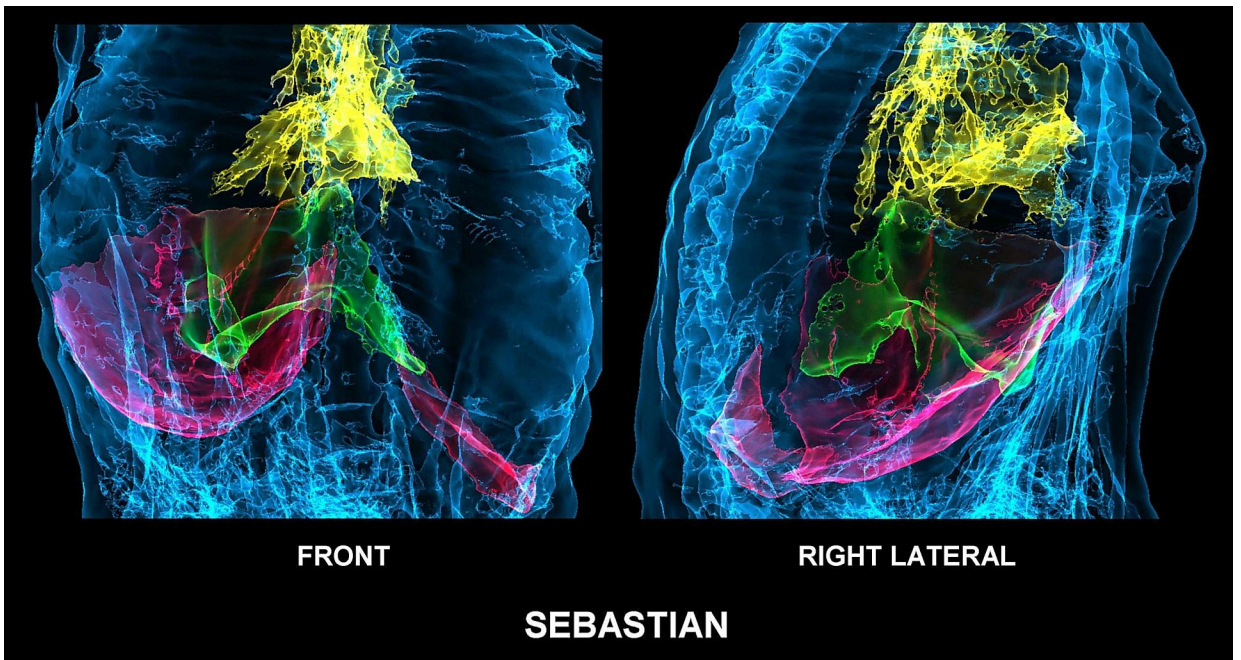
Figure 39: 3D CT showing depressed hemi-diaphragms with bilateral hemo-thoraces (*in red*) and subphrenic hematoma (*in green*). Heart (*in yellow*) appeared partially collapsed.

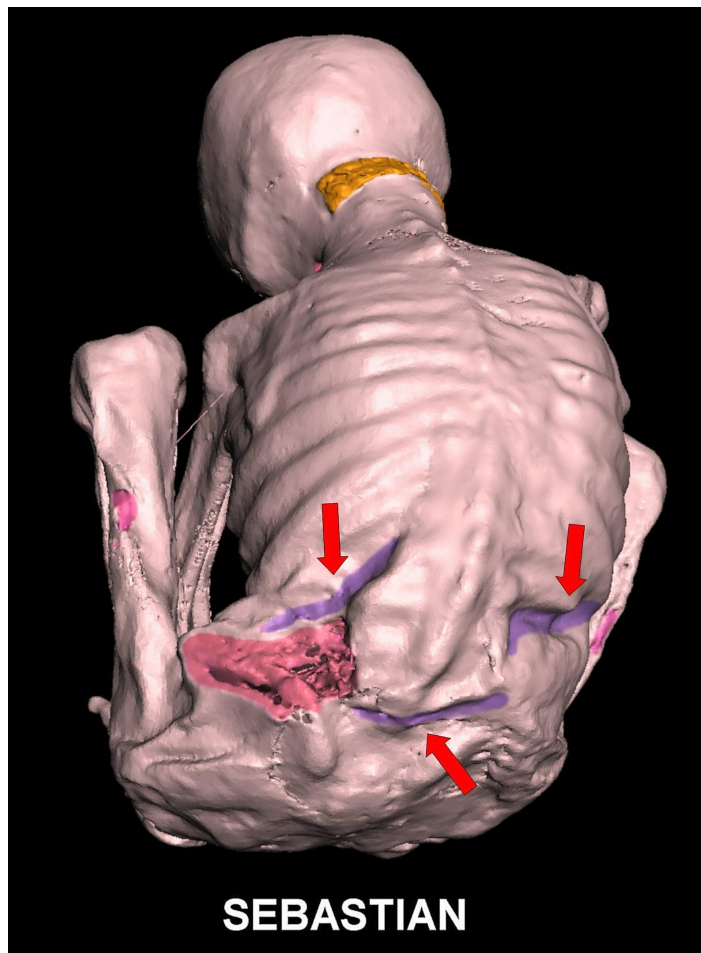
Figure 40: 3D CT showing presence of deep band shaped (*in purple*) impressions (*red arrows*) on skin surface of bilateral loins and above sacral area.

- Impression markings on bilateral loin. *(Figure 40)*
- Dislocations in left 6th, 7th, 10th, 11th costo-chondral junctions. *(Figure 41)*

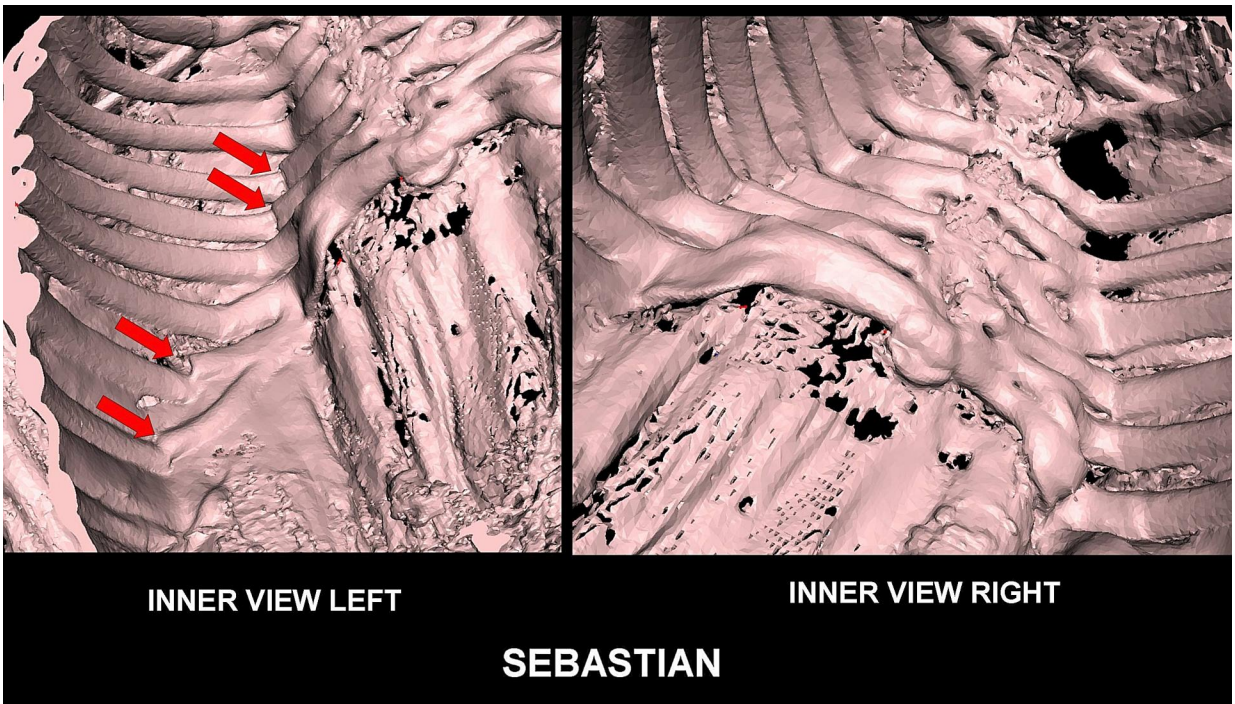
Figure 41: 3D CT showing inner aspect of thoracic cage. Subluxations were seen in left 6th, 7th, 10th and 11th costochondral junctions (*red arrows*).
